Performance loss during normal operation in a Dell Latitude E6500 laptop due to processor and bus clock throttling

Randall Cotton - recotton@earthlink.net
Revision 1.1 - July 31, 2009
© 2009 Randall Cotton

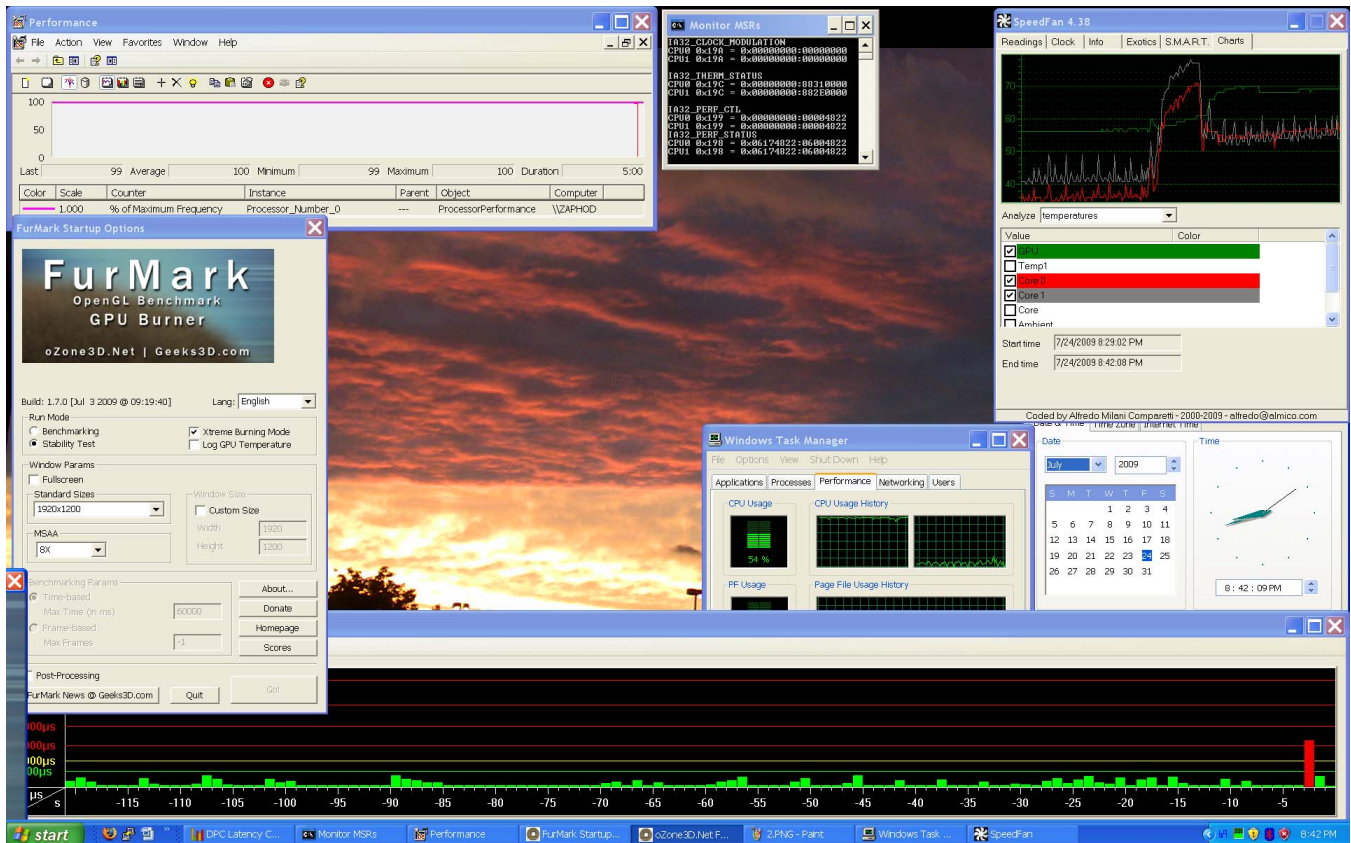
This capture was taken about 6 minutes after the Stress Prime 2004 processes were stopped and a FurMark process was started to stress the GPU (a corner of FurMark's graphics rendering window can be seen at the extreme lower left). CPU core temperatures have dropped to about 55°C and the GPU temperature is hovering around 69°C. The first throttling action has just taken place. Perfmon in the upper left shows a slight dip in the graph trace at the vertical bar cursor toward the far right of its window and the "Last" measurement is shown as 99% now instead of 100%. This indicates the transition to Performance state P1 from state P0. DPC Latency Checker, along the bottom, recorded the switch as having occurred 3 seconds prior to the capture. All throttling events, in fact, are marked by such conspicuous latency spikes. The Intel Core 2 Duo's IA32_PERF_CTL Model-Specific Register now shows a different value in the "Monitor MSRs" window, indicating that a performance state change was requested of the CPU.

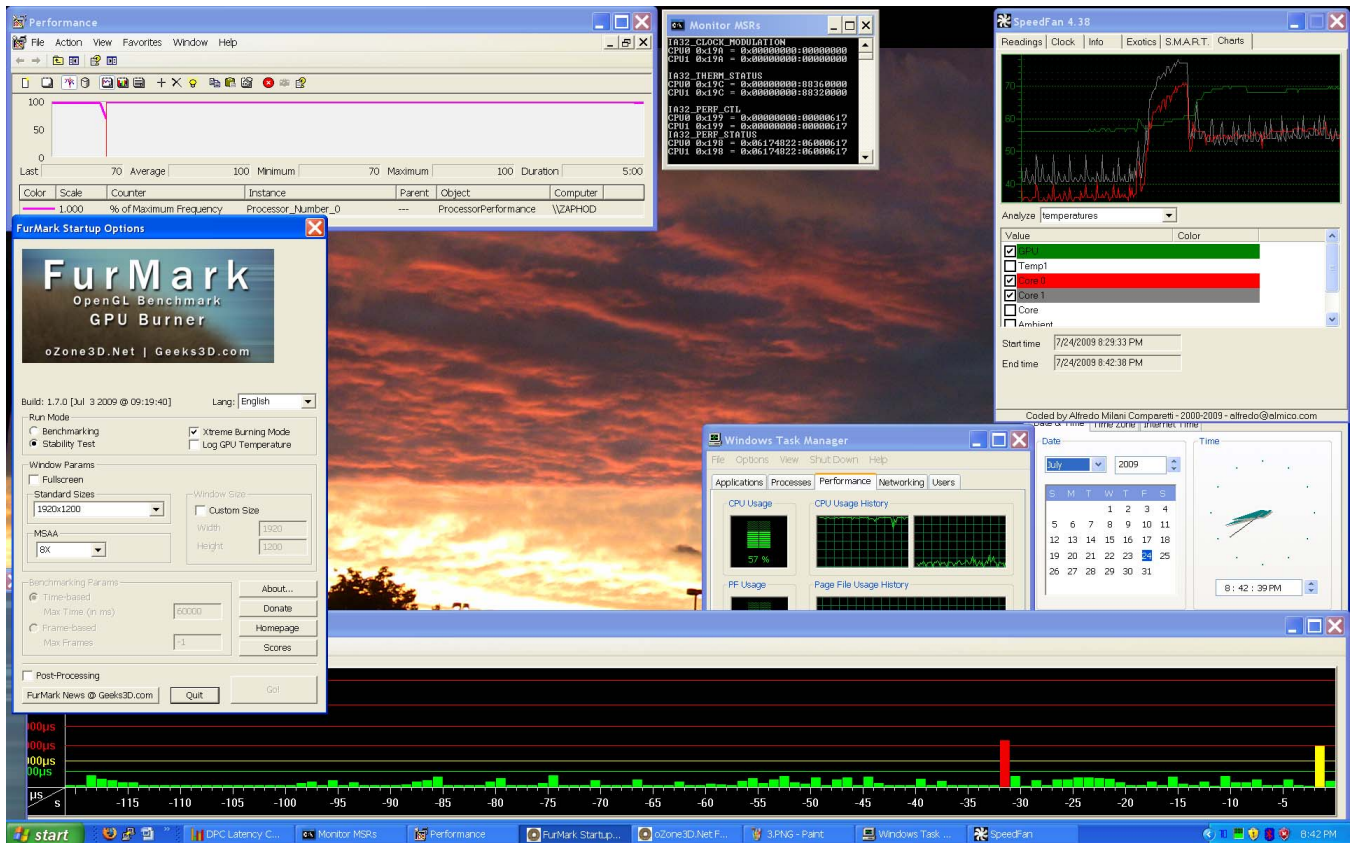
Here the second throttling event takes place exactly 30 seconds after the first. All throttling events, in fact, are observed to take place only at 30 second intervals. This is consistent with an always-present running process that polls temperatures and takes throttling action every 30 seconds. Perfmon shows the decline in performance to 70% and IA32_PERF_CTL indicates the new P-State change request.

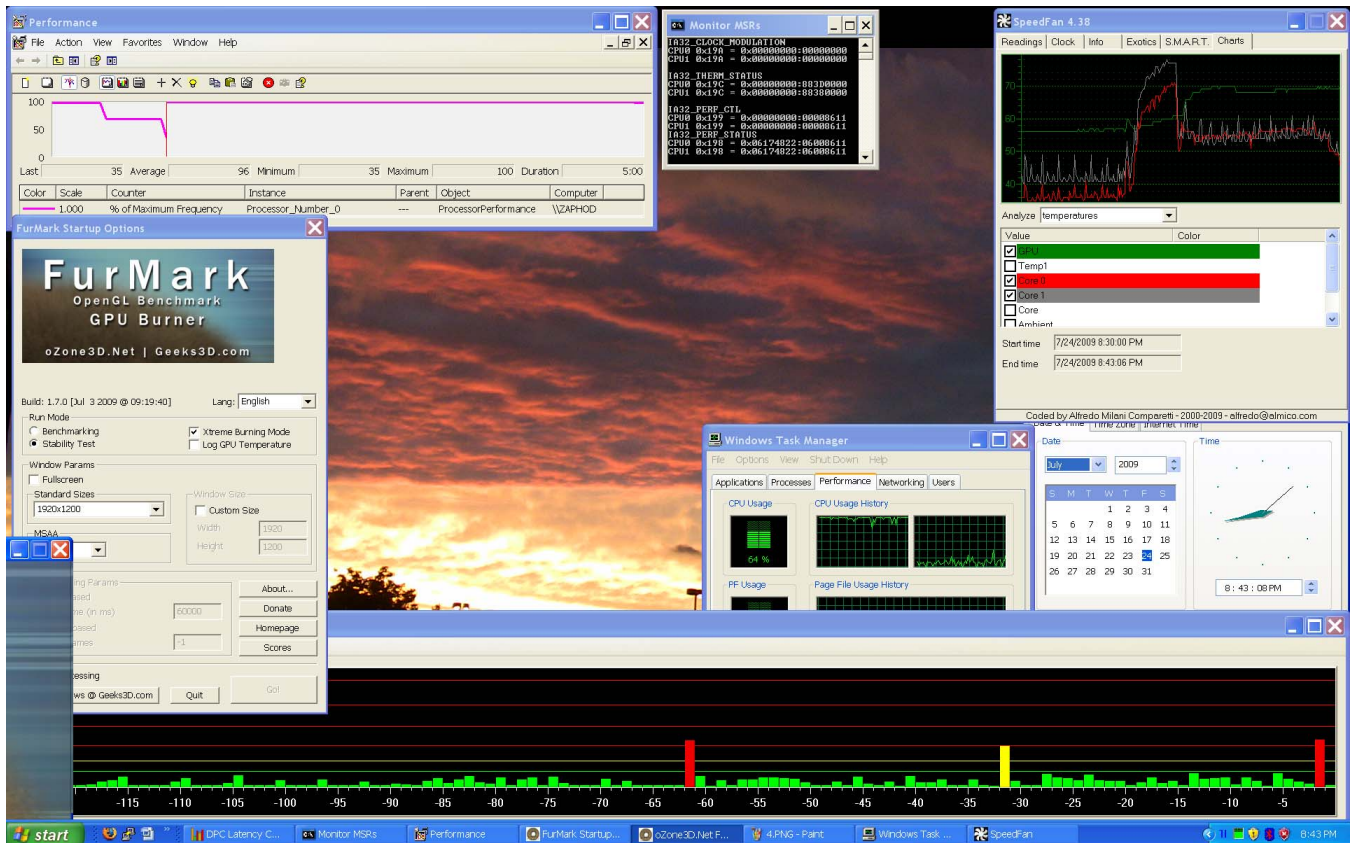
30 seconds later, the 3rd throttling event takes place. Perfmon shows %processor utilization is now down to 35% and IA32_PERF_CTL shows yet another value corresponding to the request for a change to performance state P3 (the lowest-performance P-state). Note that the position of the FurMark rendering window in the lower left is being shifted from time to time to make small adjustments to the GPU load so that the GPU's temperature is maintained around 69°C. The more of FurMark's rendering window is actually exposed on the Desktop, the higher the demand on the GPU.

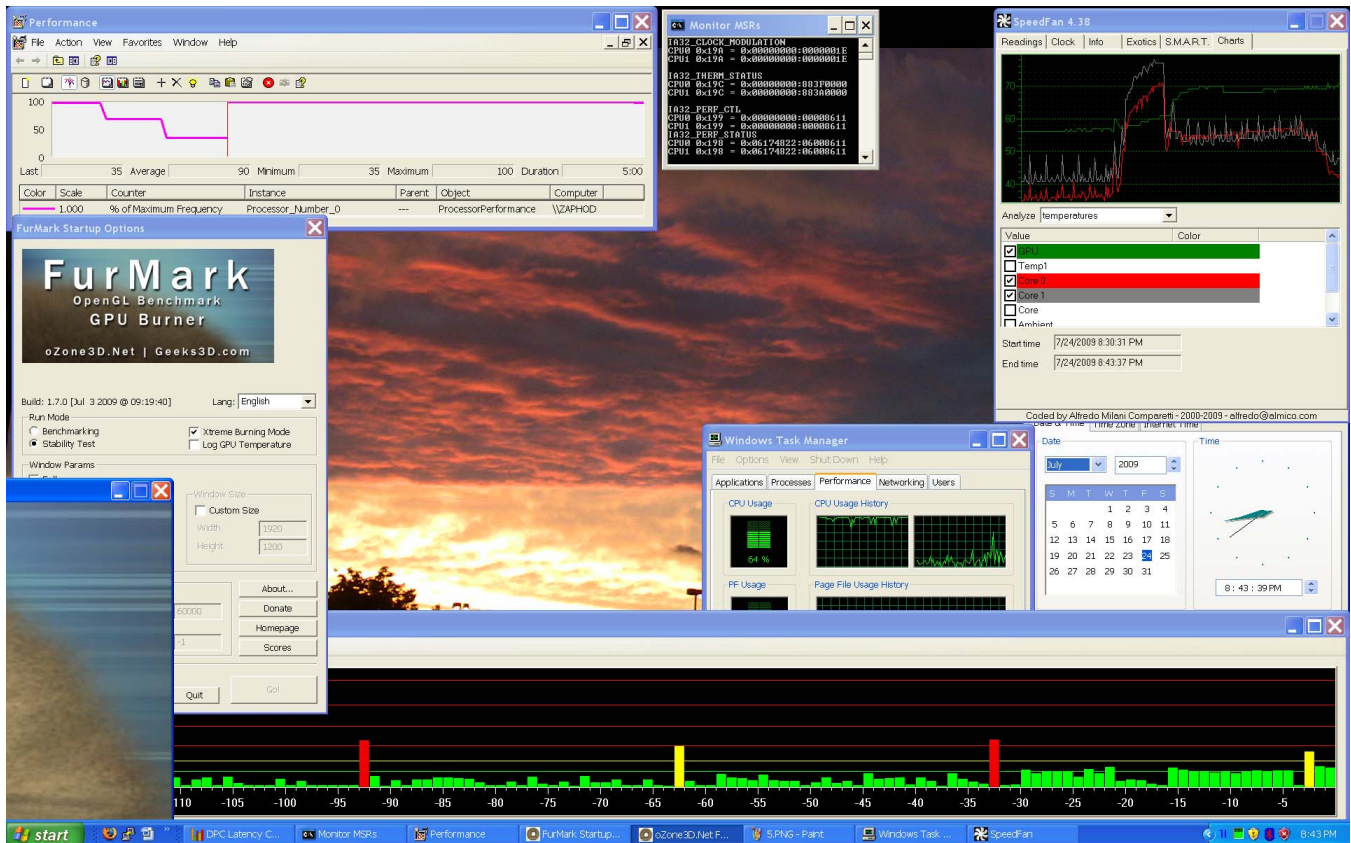
At this point, the system is already at the lowest performing P-State (P3), so at this next 30 second interval, Software-controlled Clock Throttling begins. The CPU's IA32_CLOCK_MODULATION MSR is now showing that modulation is engaged and throttling is now at 87.5%. The register codings are published in Intel documentation available online. The values for IA32_CLOCK_MODULATION are as follows¹¹:

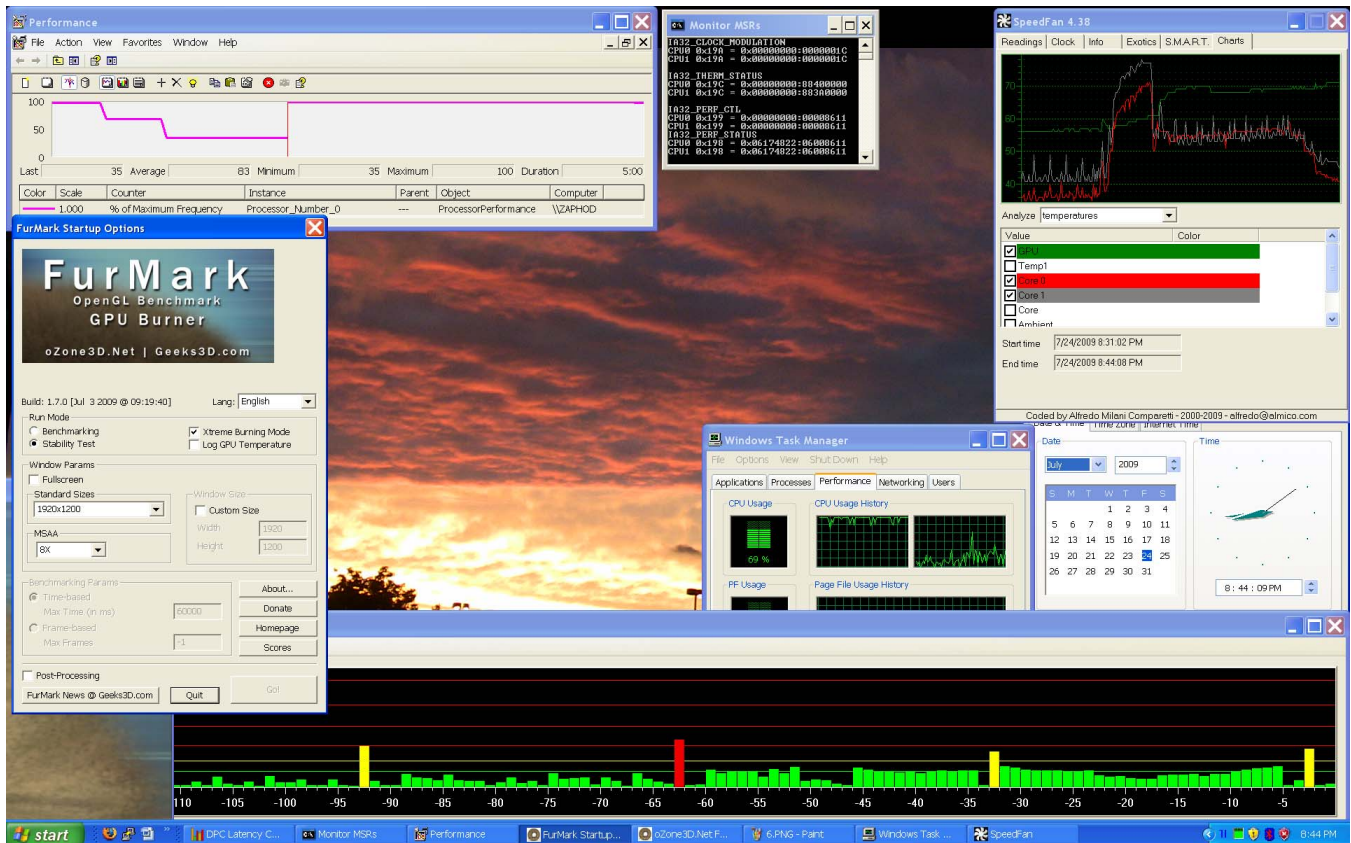
At the next 30 second interval, clock modulation increases to the next step so that processor performance is downgraded another 12.5% to 75%, as indicated by the new value for IA32_CLOCK_MODULATION. While CPU core temperatures are dropping due to the downclocking, the system's performance is also declining. The system becomes increasingly sluggish and unresponsive. Average DPC latency is also increasing significantly, as shown by the graph along the bottom, a concrete indicator decreasing system performance.

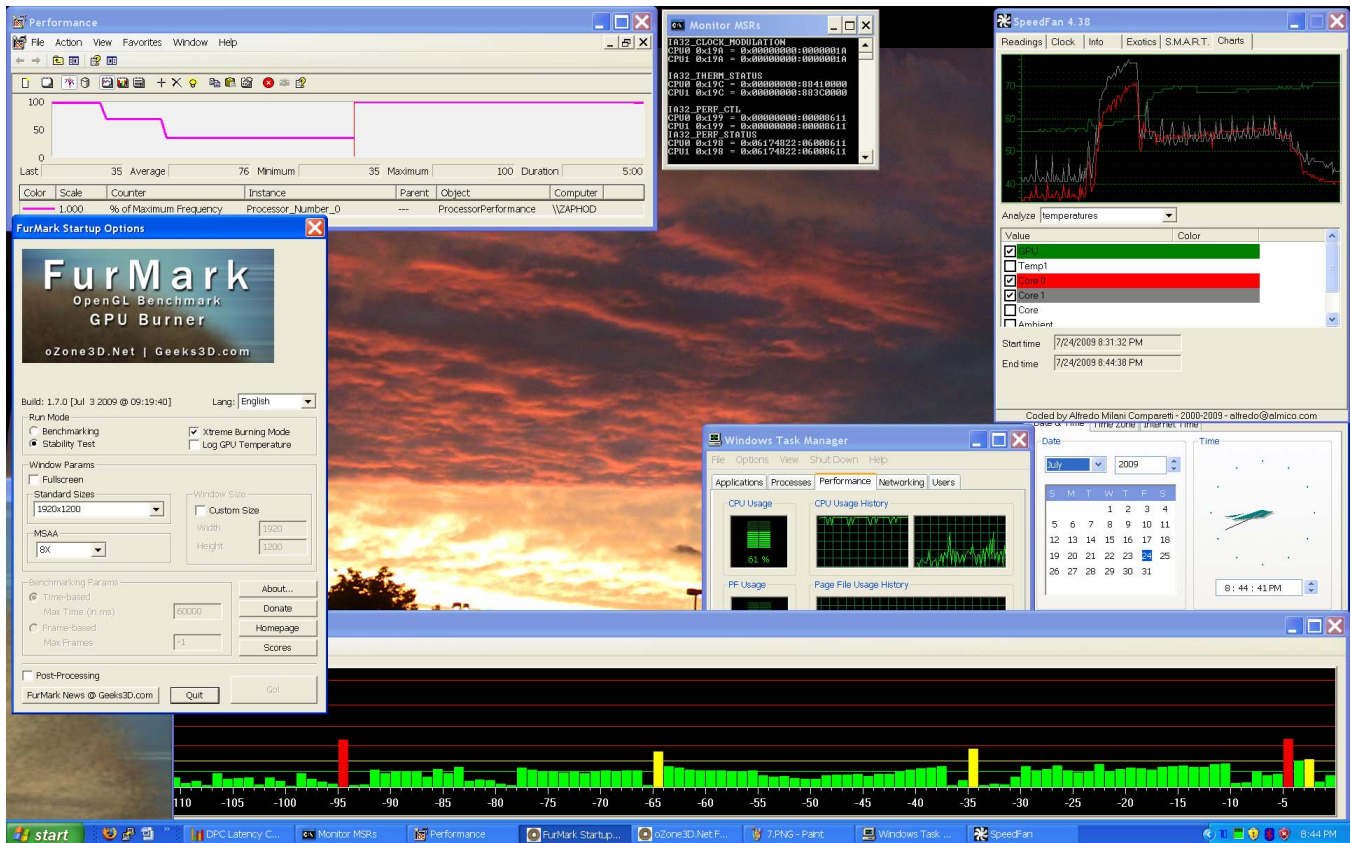
Right on schedule, clock modulation is escalated to the next level, now leaving the system at 62.5% of state P3's performance. Note that while CPU core temperatures have fallen dramatically, almost to idle levels before the testing began, the throttling continues unabated, demonstrating a strong correlation between throttling engagement and elevated GPU temperatures and little correlation with CPU temperature (though some correlation with CPU temperature is demonstrated later in this test session).

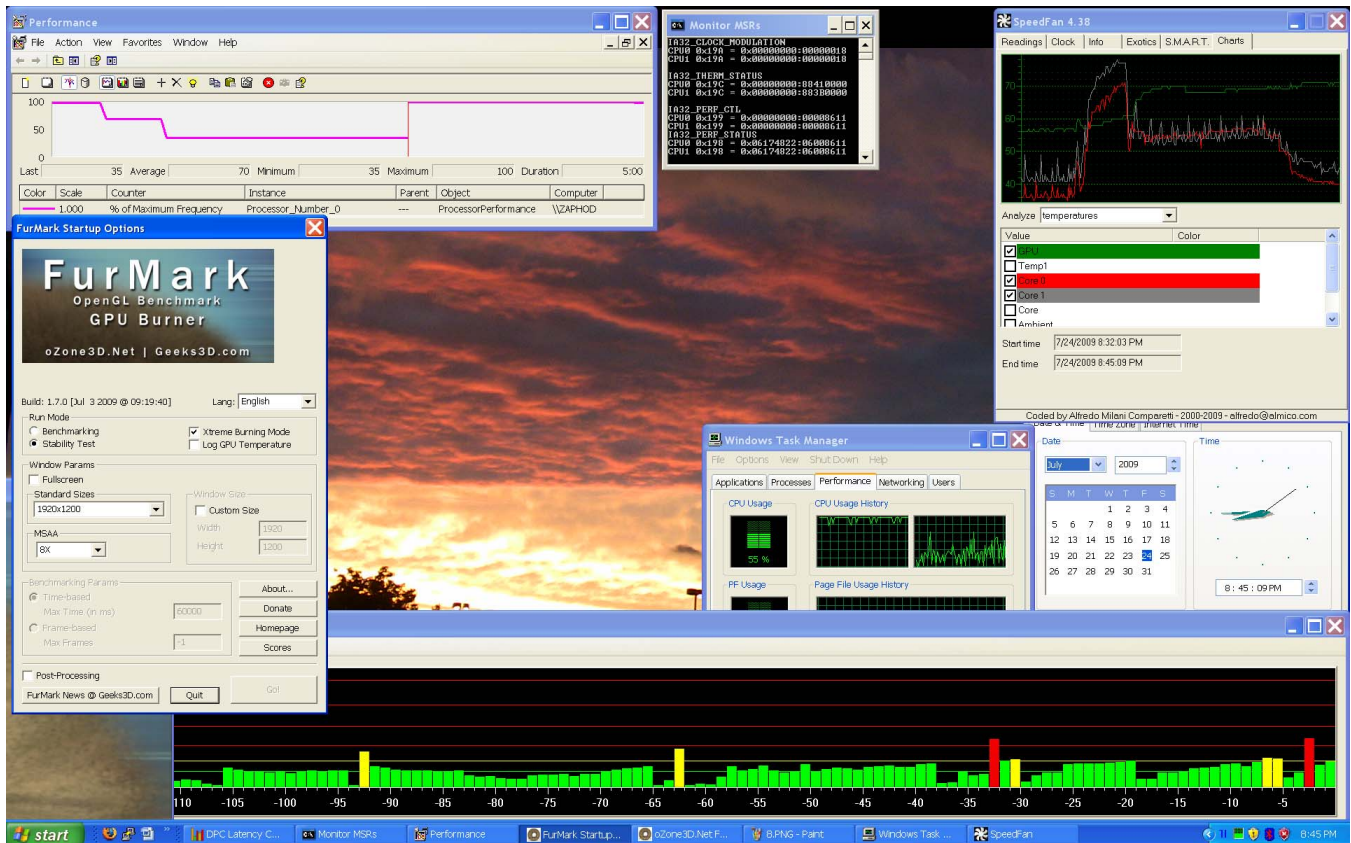
Throttling escalation continues. DPC latencies are approaching 1ms on average.

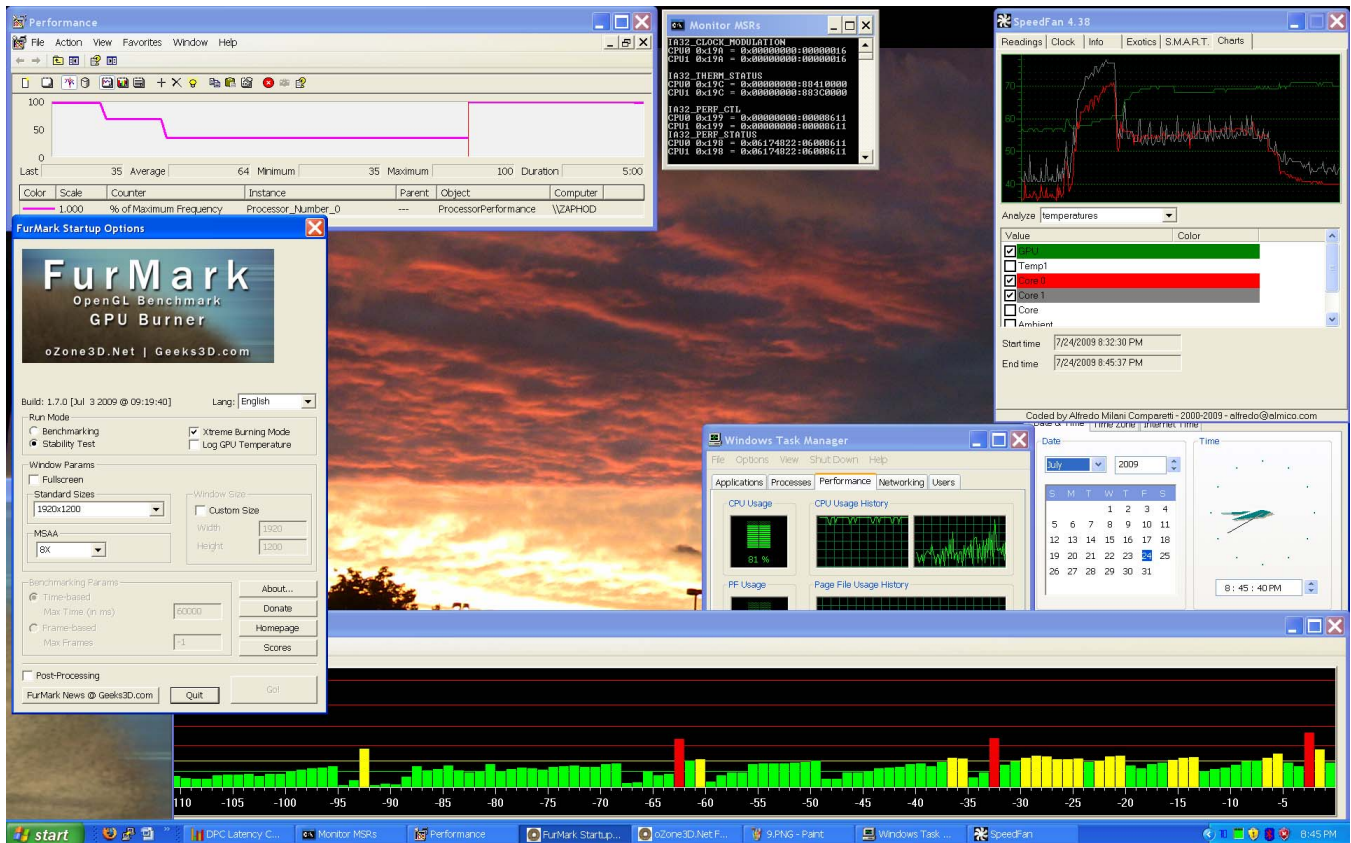
As the system performance continues to decline, baseline DPC latencies begin to take off as clock modulation is escalated (now down to 37.5% of state P3's performance).

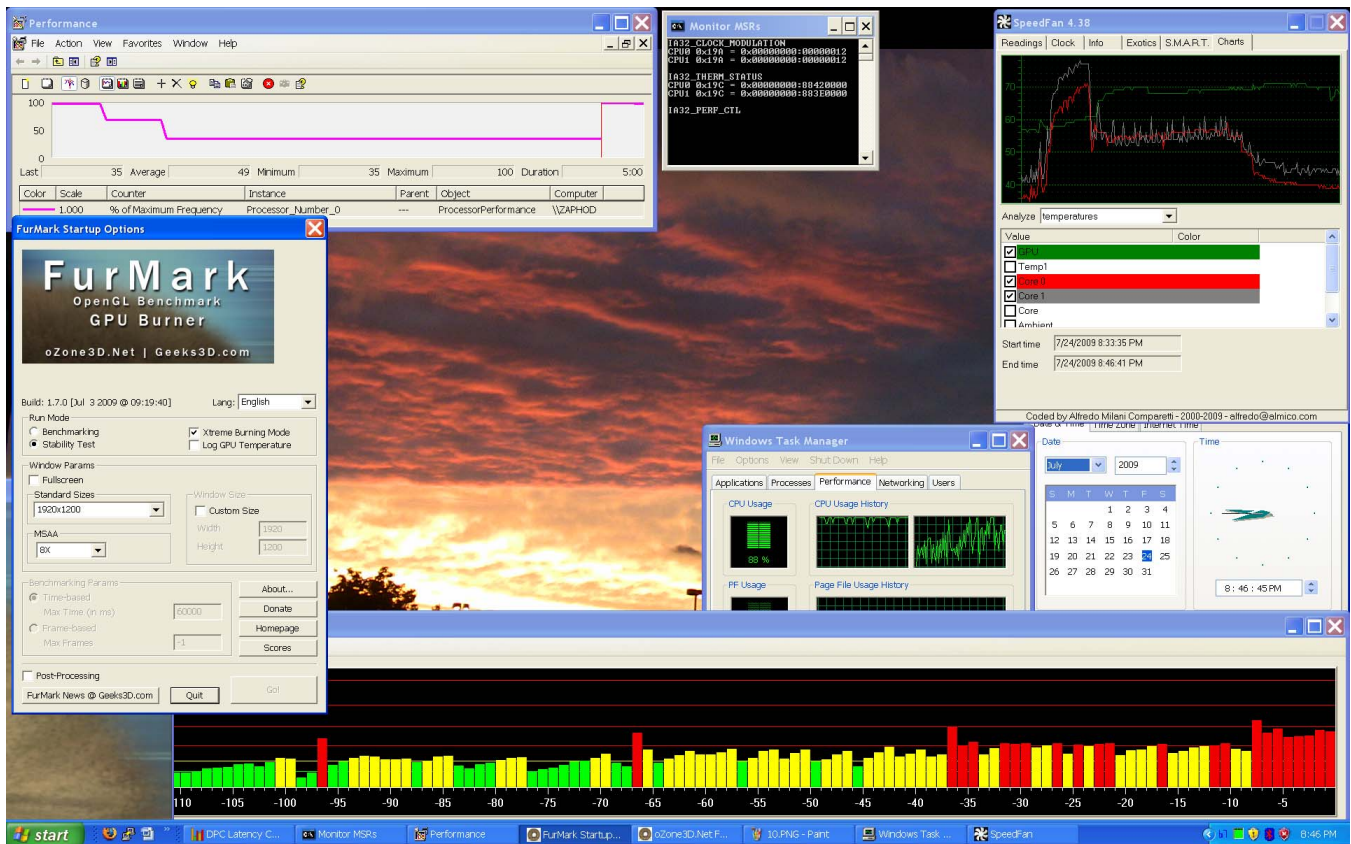
The system is now throttled to 12.5% of state P3's performance (which is a state that was already downgraded to 798MHz with a half-speed Front Side Bus). The rough equivalent processing power for this 2261MHz system is now around 100MHz, according to numbers already highlighted from Intel's publications regarding these throttling features. However, throughout the entire throttling process, no internal temperature exceeded 70°C, itself a routine operating temperature. At this point, the FurMark rendering process was stopped to see how the system would recover.

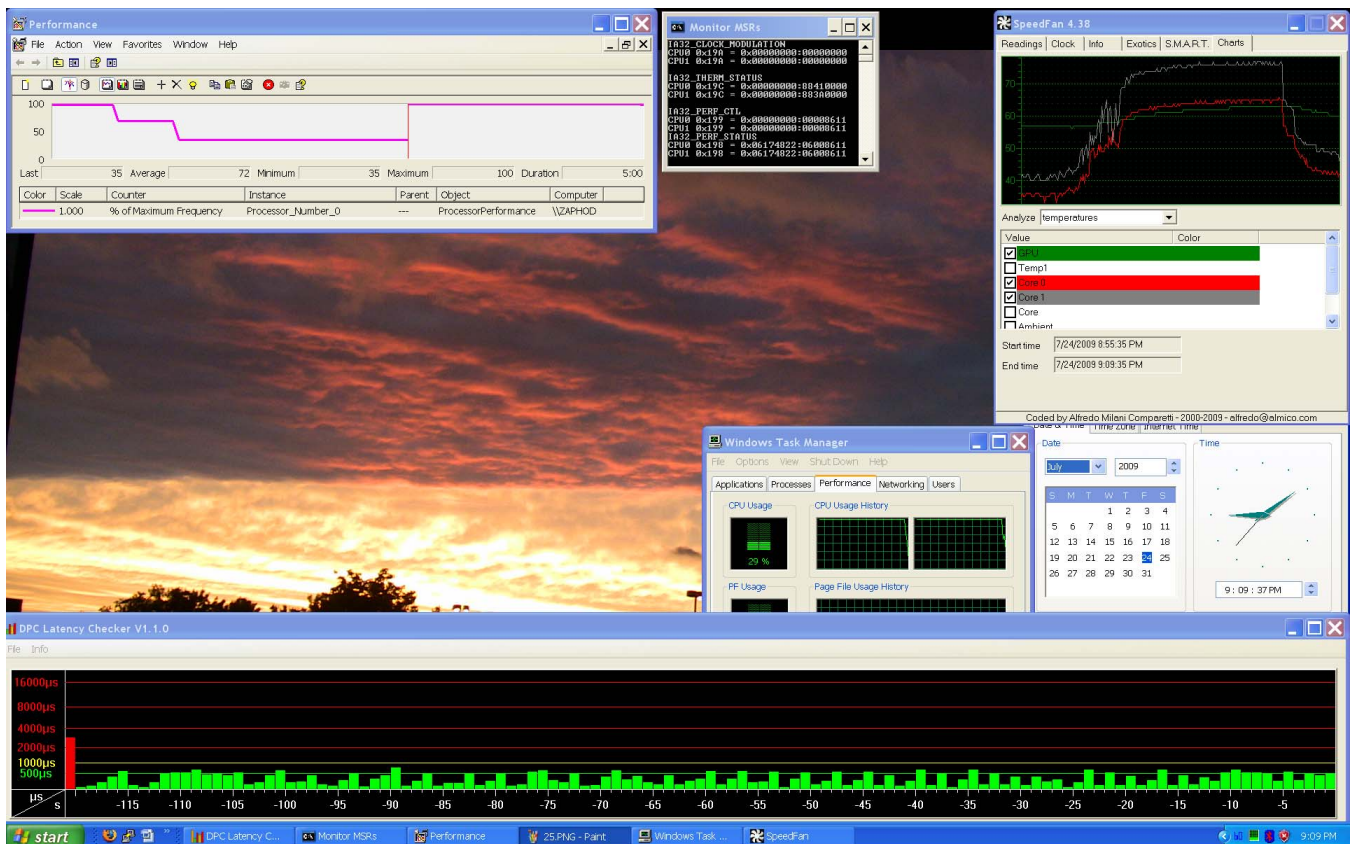
But then there are no more transitions. That is, throttling stopped with the transition to P3 (which is shown on the far left of DPC Latency Checker's window, having taken place about 2 minutes prior). It would appear that the polling process took the dramatic drop in CPU temperatures into account and decided no further throttling was necessary. So it appears that CPU temperatures do have some effect, though this test and later tests show that GPU temperature determines, much more than the CPU, whether and when throttling takes place.

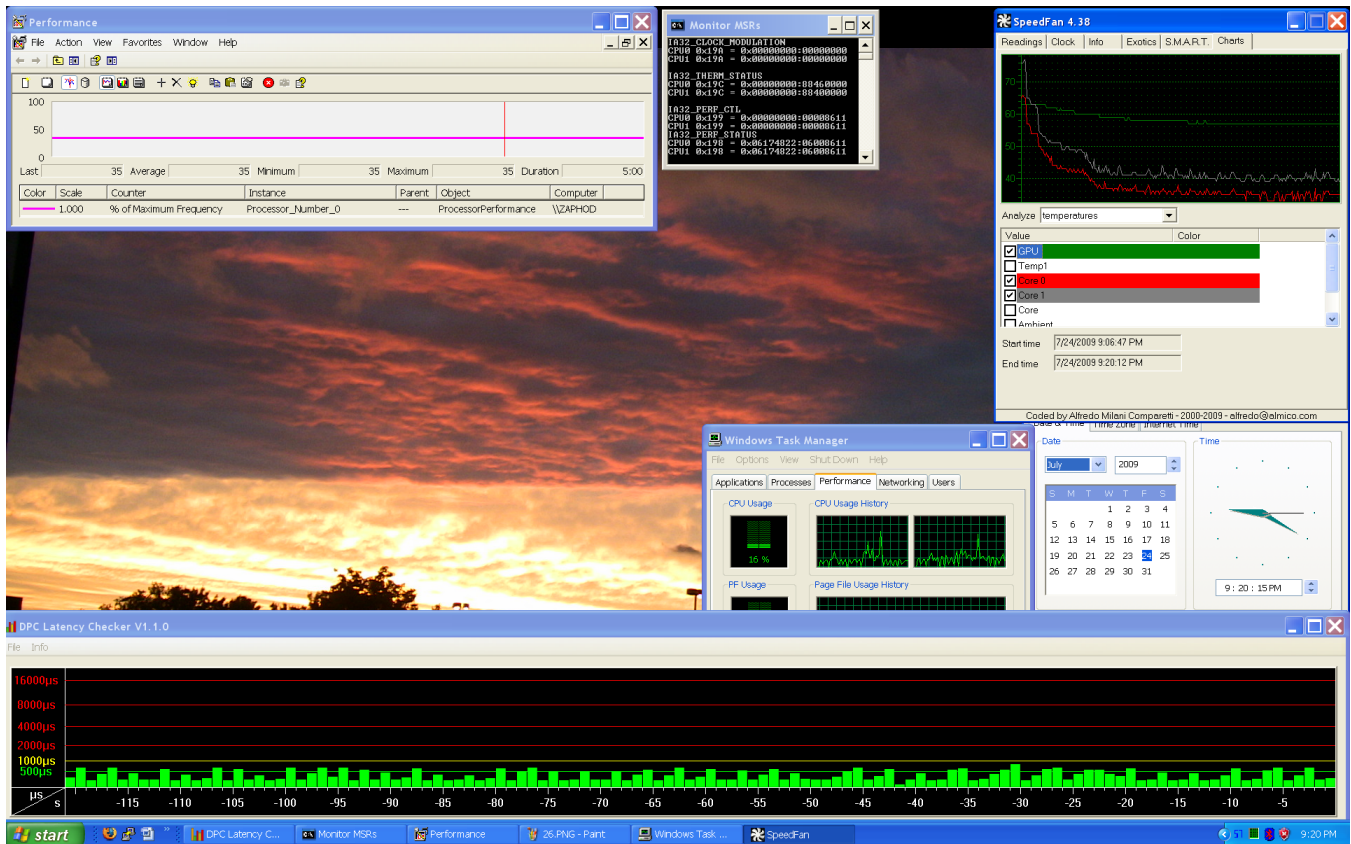
More than 10 minutes later, however, despite temperatures having returned to normal idle levels, performance is still substantially throttled, remaining at 35% with a half-speed Front Side Bus.

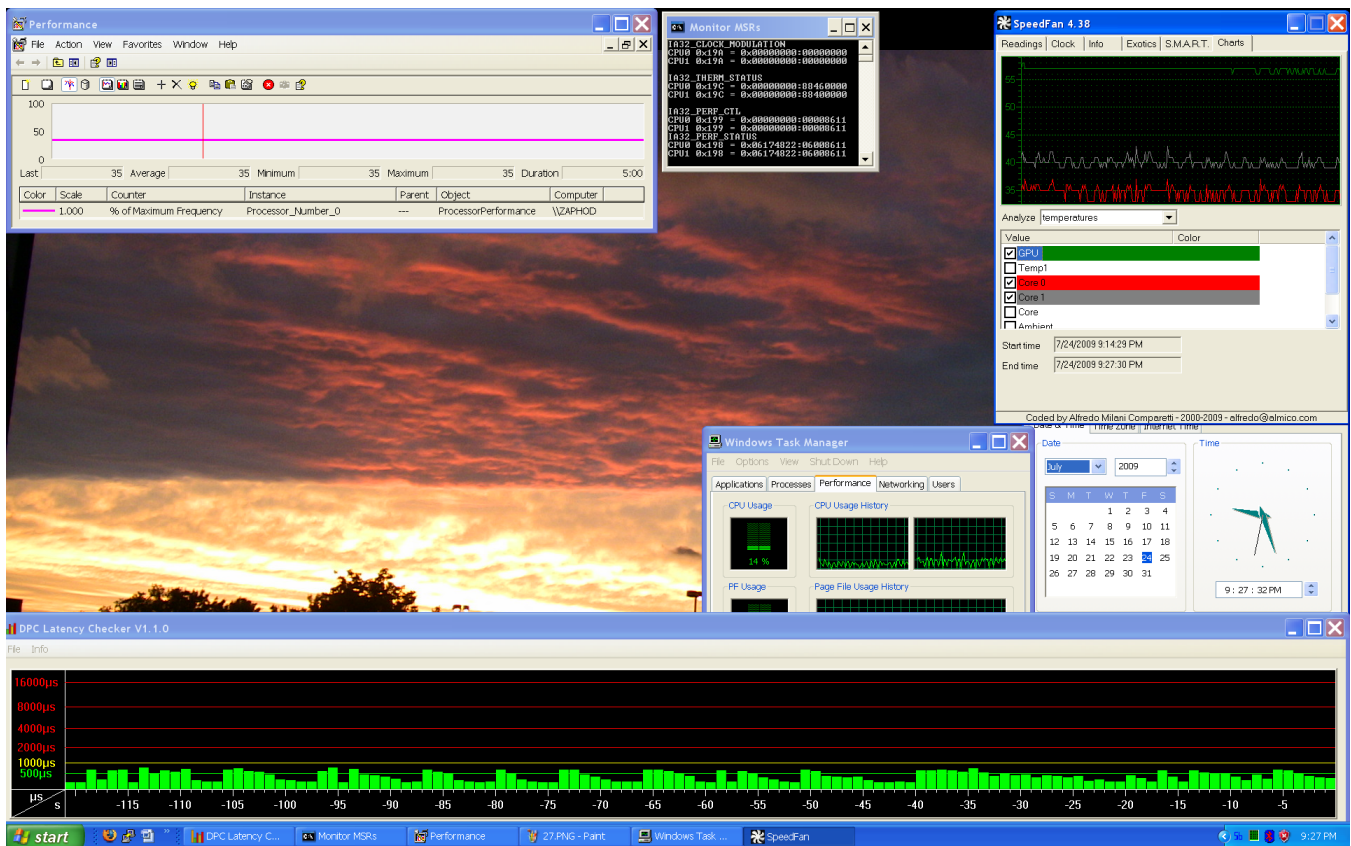
Now 18 minutes since the calculator processes were stopped, but throttling is still in place.

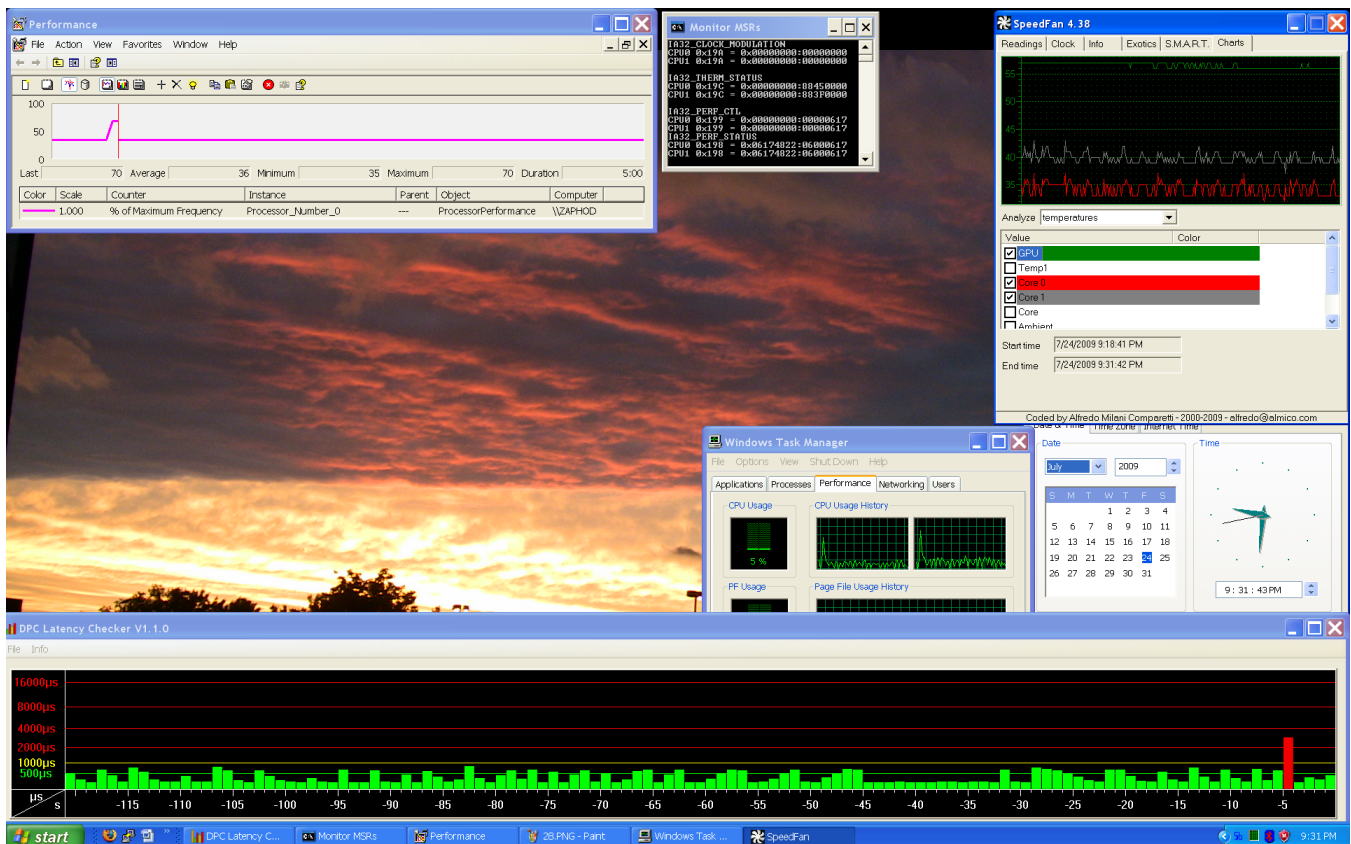
More than 20 minutes after the system was left idle, throttling was still in effect. Moments before this screen capture above, a small desk fan was aimed toward (but not directly at) the right side of the docked E6500 to create a gentle circulation of air in an attempt to nudge the system into reversing the throttling. That effort was successful as the transition to state P2 from P3 did finally take place as shown above.

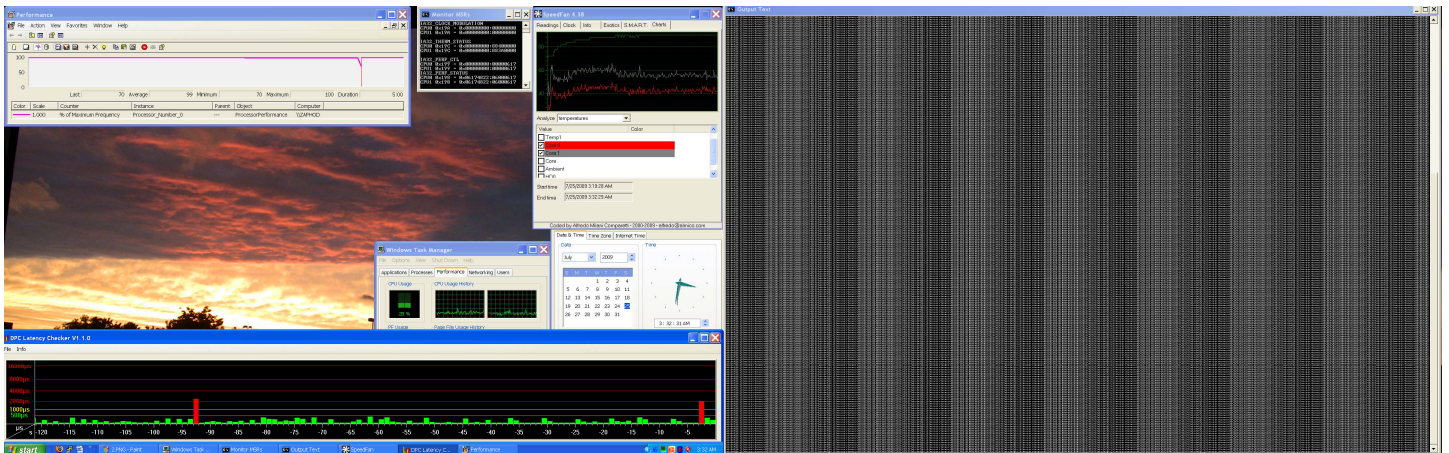
At this point, about 13 ½ minutes into the test, the first two throttling events have occurred, even though GPU temperature is only at 65°C and the CPU cores remain under 50°C. The first two events shown didn't take place 30 seconds apart, but they were still separated by 30 second intervals (90 seconds apart).

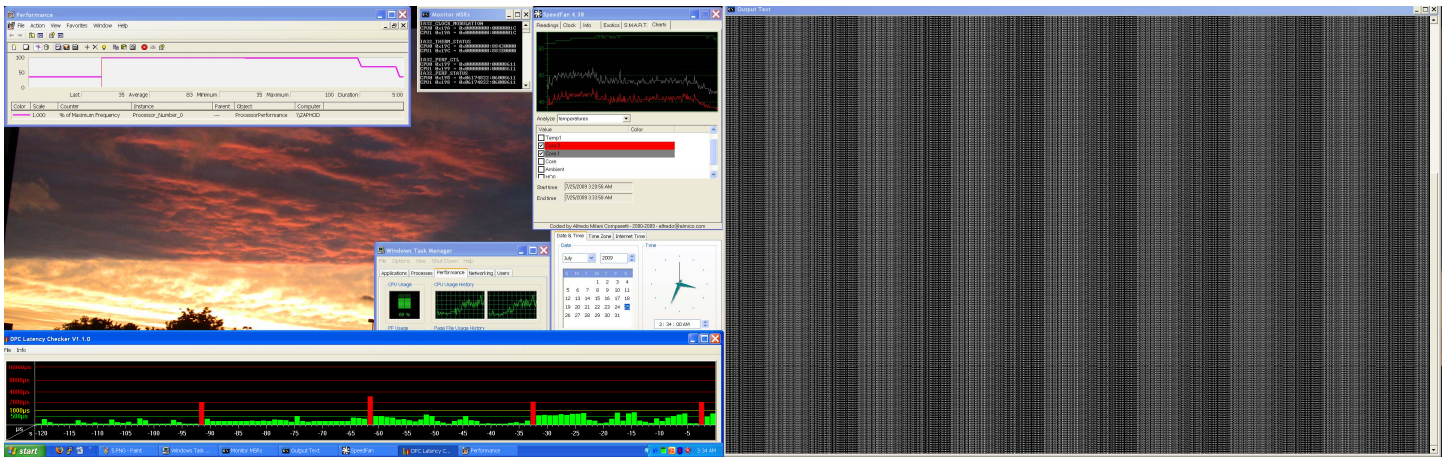
At this point, one and a half minutes later, 3 additional throttling events have taken place. The system is now degraded by Software-controlled Clock Modulation to 75% capacity of performance state P3, for an equivalent processing power of about 600MHz.

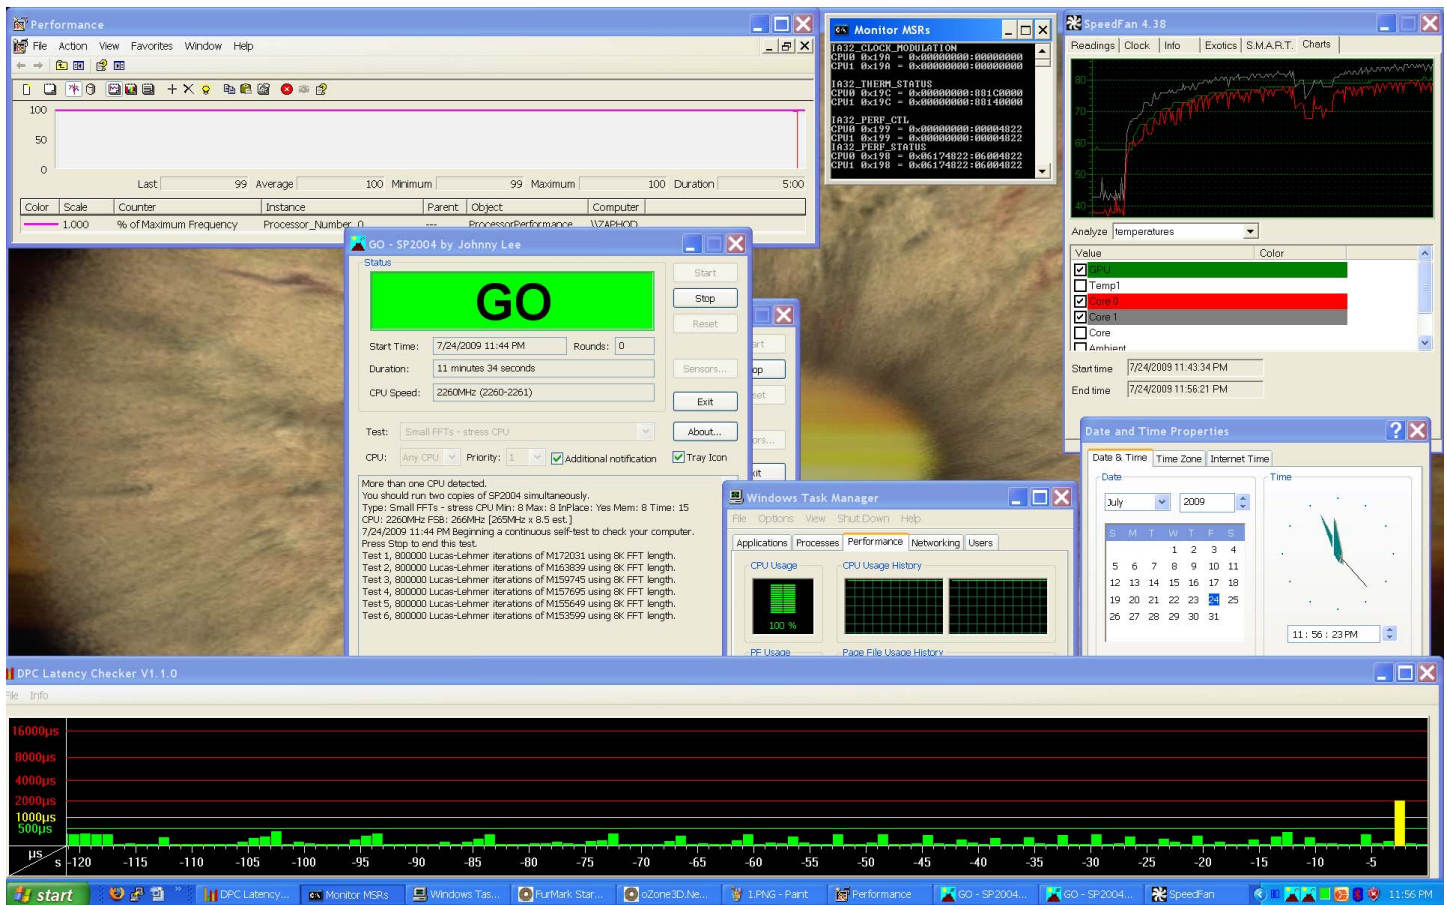
About 12 minutes later, the first throttling event occurs. The image in the background is the FurMark rendering window. GPU temperature is just over 80°C, about 10°C higher than when throttling was first triggered in the docked single monitor configuration test and about 15°C higher than in the docked dual monitor configuration test. 80°C is still well within CPU and GPU designed operating range.

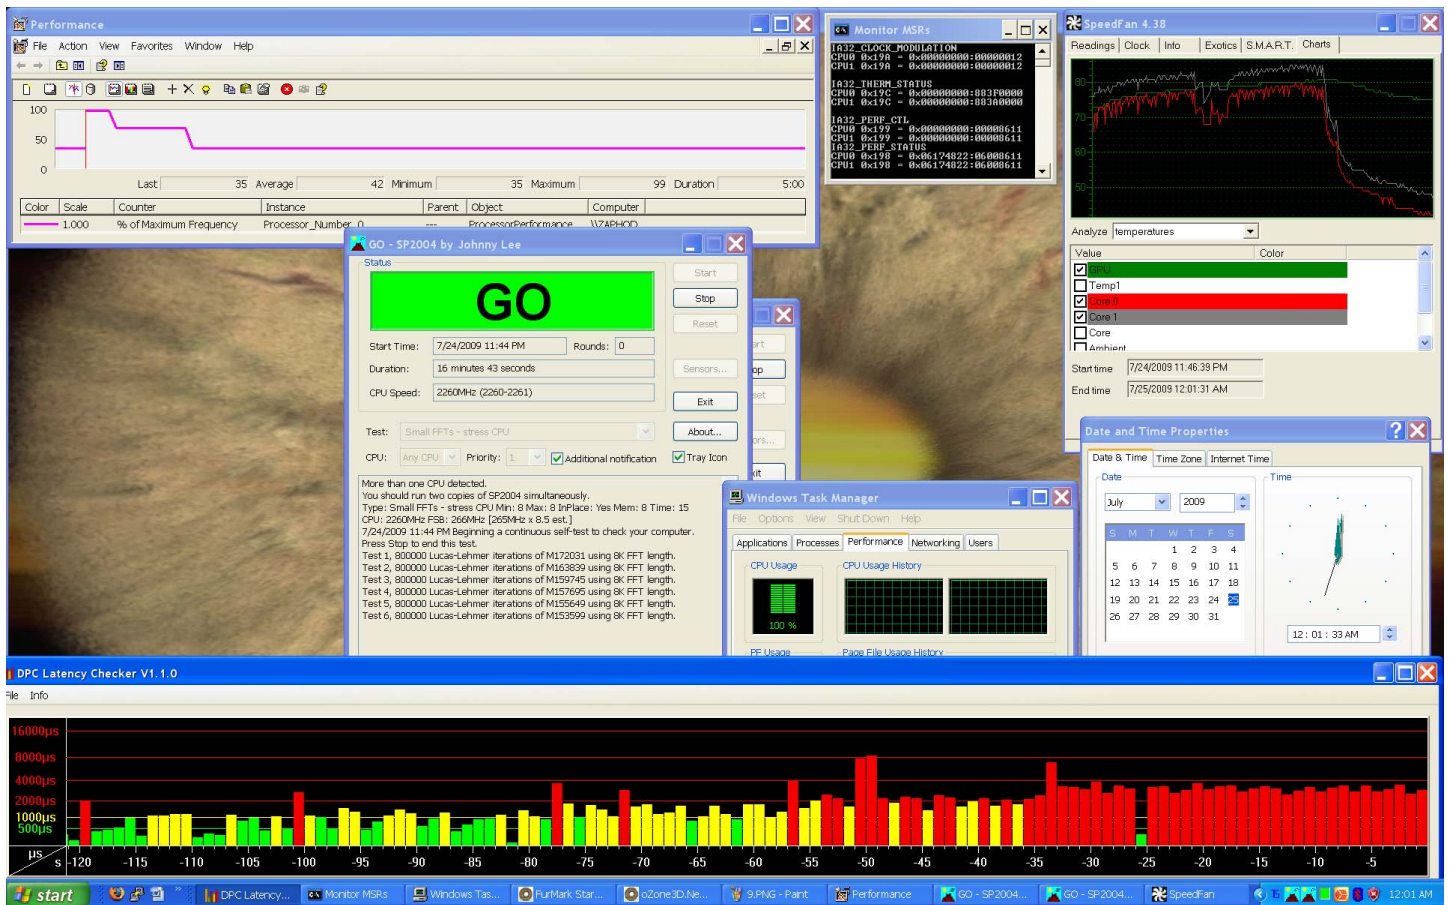
The remaining 3 throttling steps are shown to have occurred here, leaving the system fully throttled (12.5% of the P3 State, or about 100MHz overall, compared to its 2261MHz capacity). Both the FurMark and Stress Prime utilities were stopped just after this capture.

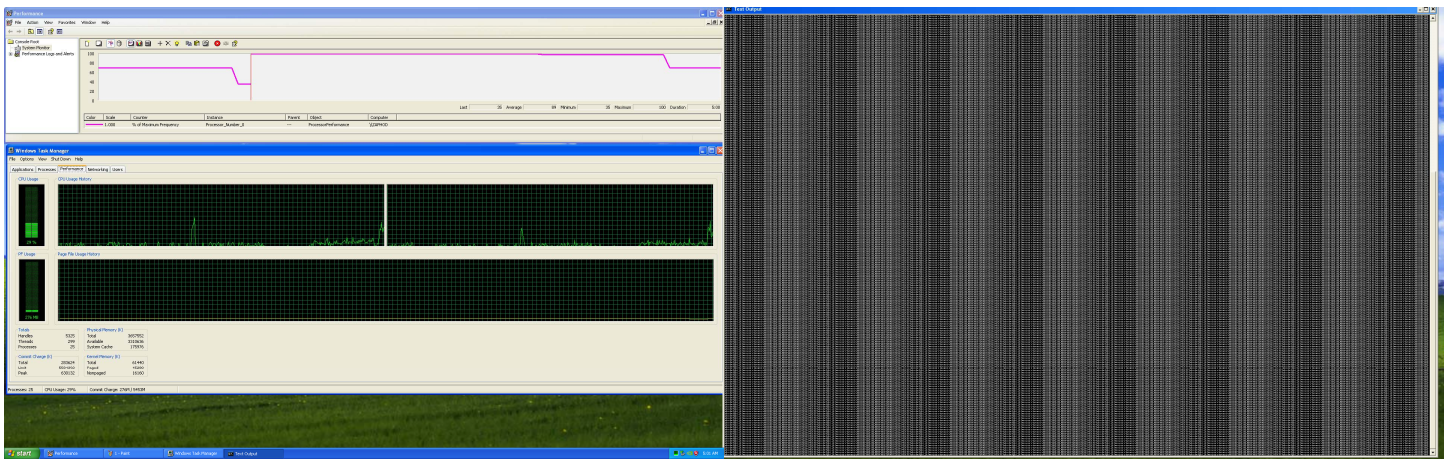
Though it took longer to trigger throttling in this case, half an hour later the system was throttled down to at least 35% of its true capacity. It wasn't possible to measure whether Software-controlled Clock Modulation was engaged since third-party software was not a part of this test by design. However, it stands to reason that this is the same throttling mechanism observed in prior tests, particularly since the throttling events occurred at the usual 30 second intervals (the P1→P2 and P2→P3 transitions were separated by 60 and 90 seconds, respectively). The batch file was stopped immediately after the screen capture above.
