Performance loss during normal operation in a Dell Latitude E6500 laptop due to processor and bus clock throttling

Randall Cotton - recotton@earthlink.net
Revision 1.1 - July 31, 2009
© 2009 Randall Cotton

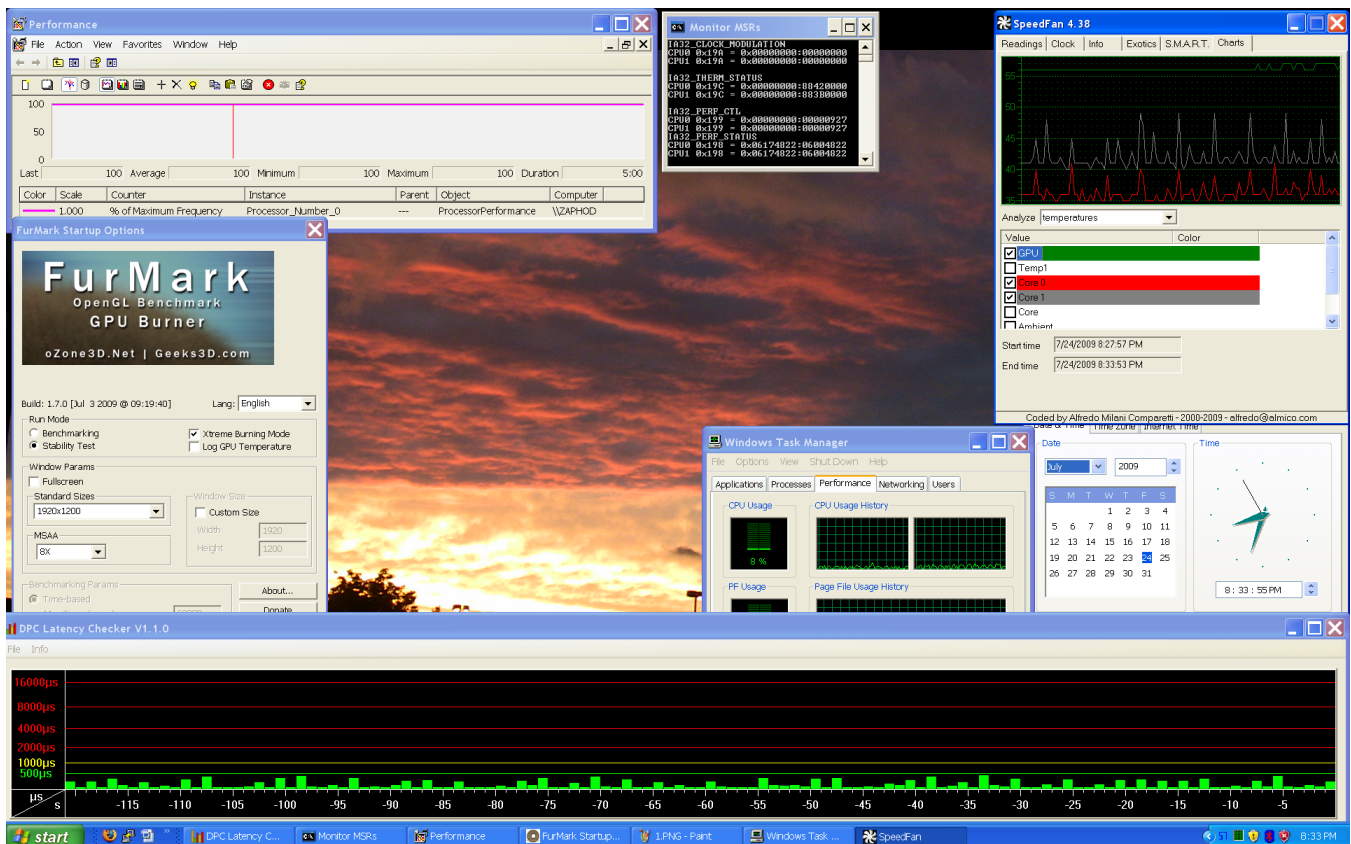
In this first screen capture, taken before the testing begins, it can be seen that the system is at full processor capacity (100% of maximum frequency according to perfmon in the upper left corner), the GPU temperature is about 56°C and CPU core temperatures are averaging around 36°C and 42°C (according to SpeedFan in the upper right), the system has been idle for some time (according to Task Manager), DPC latencies are under 500 microseconds (according to DPC Latency Checker along the bottom) and FurMark has not yet been started. Ambient room temperature at the time of this test is 28.5°C.

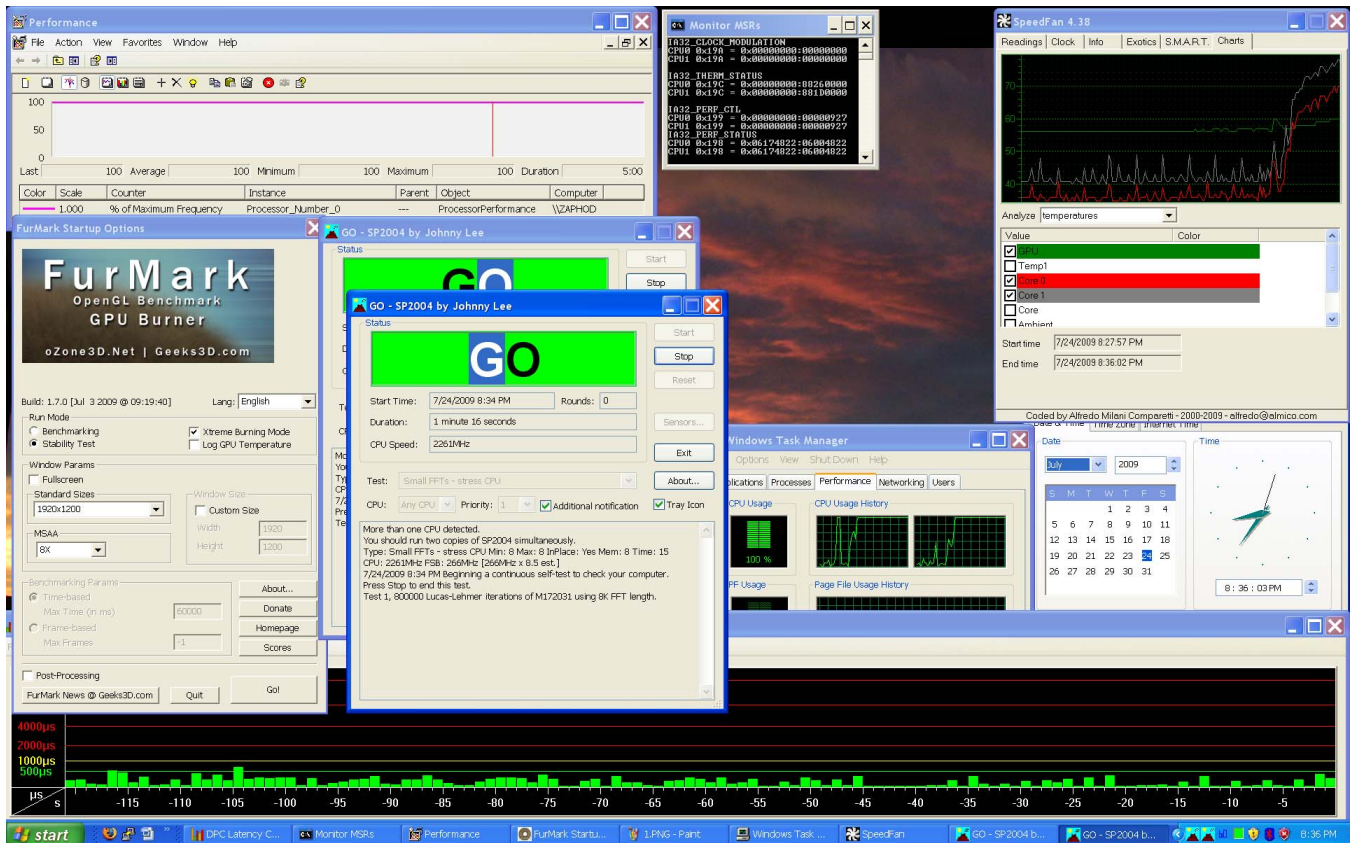
To begin with, demonstrating a point that will be expanded on later, two instances of Stress Prime 2004 are started to heat up the processor cores until they're both above 70°C (when this screen capture was taken). This was done to demonstrate that no throttling takes place when this happens. The next step will be to heat up the NVIDIA Quadro NVS 160M to just under 70°C, where we'll see that throttling *does* take place.

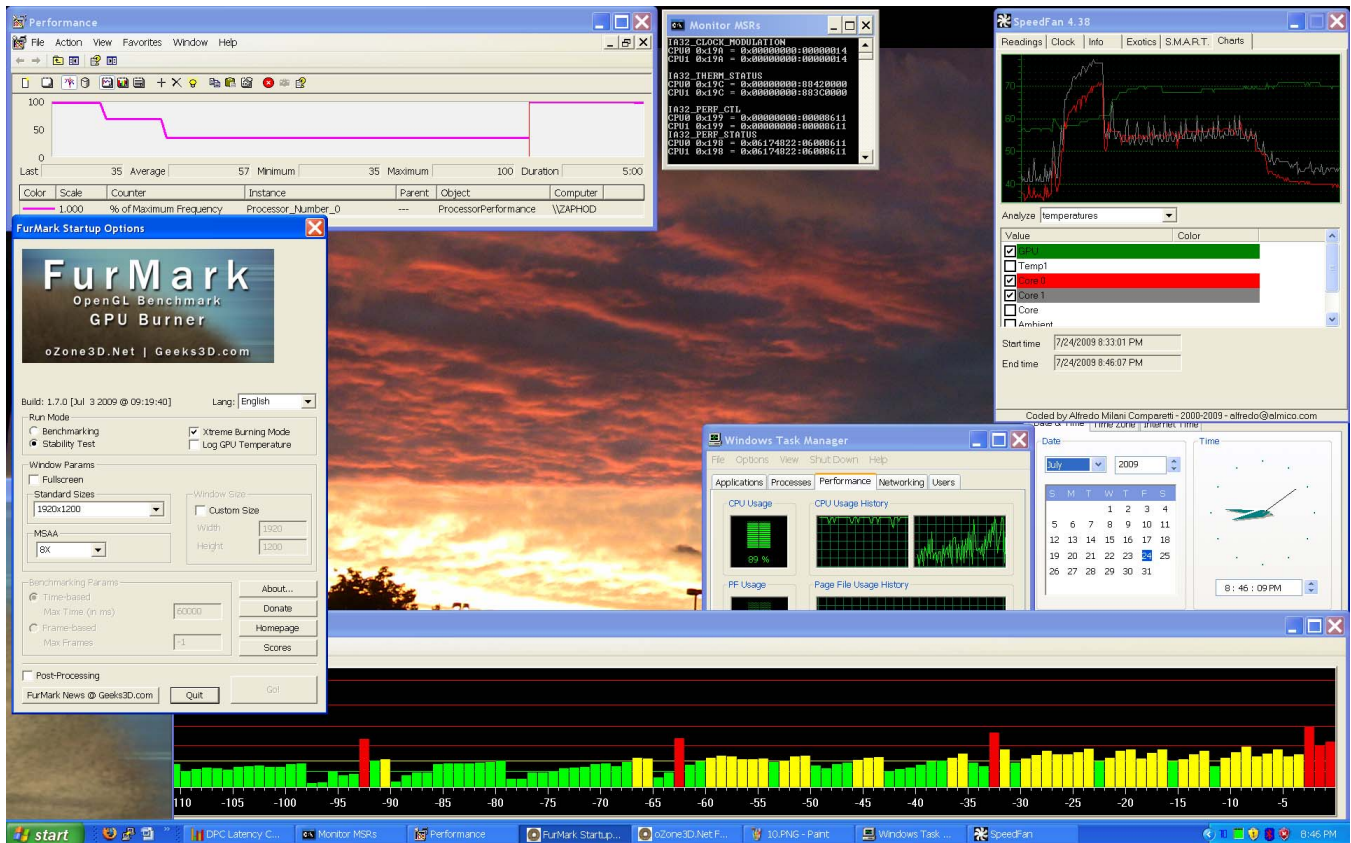
There is one more throttle event left.

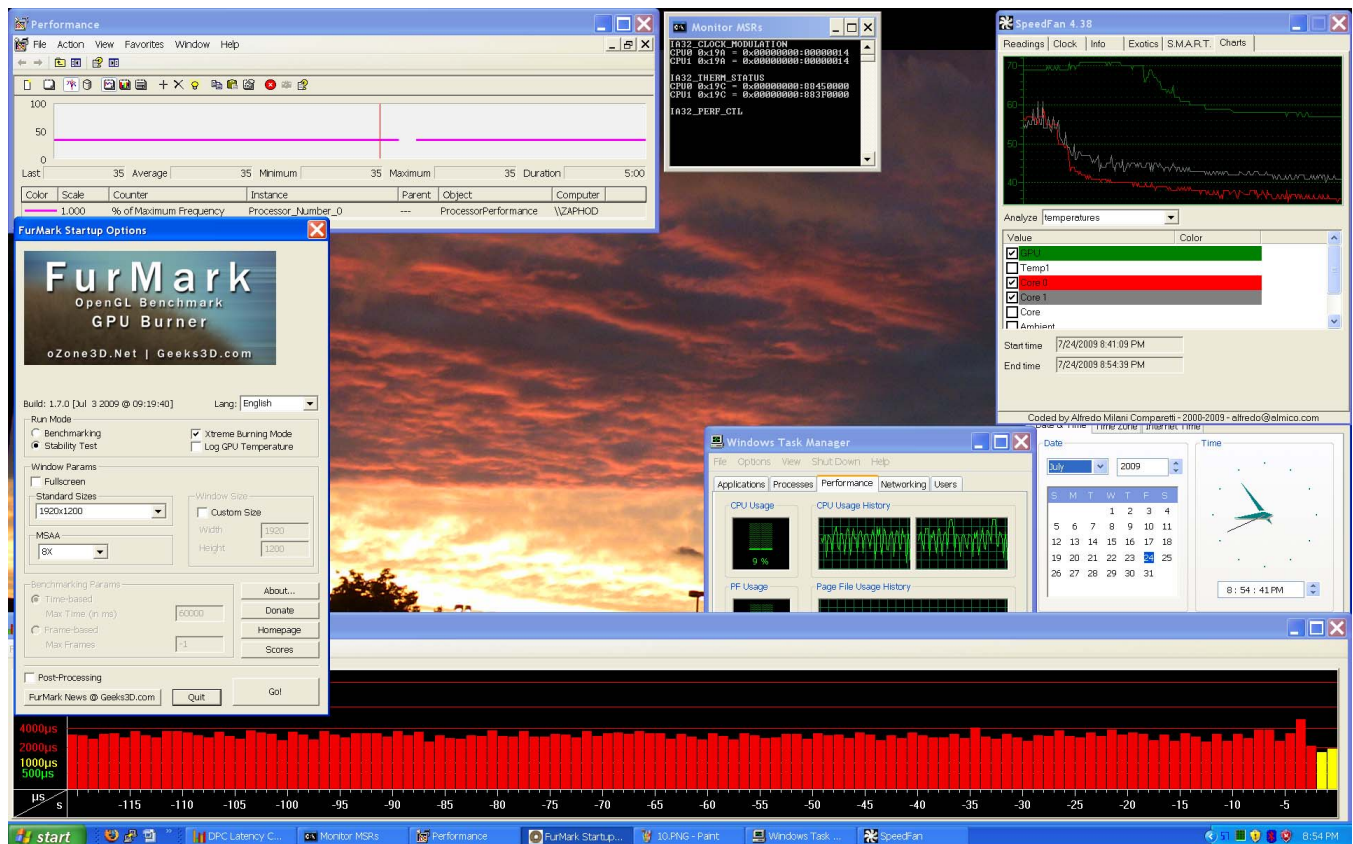
About 10 minutes later after the system slowly cooled off (chronicled in the SpeedFan graph in the upper right), reversal of the throttling began. The IA32_CLOCK_MODULATION register confirms the throttling transition to 25% (from 12.5%). The accompanying DPC latency spike (smaller than usual in appearance, but still substantial since the graph scale is logarithmic) records that the transition occurred 4 seconds before this screen capture.

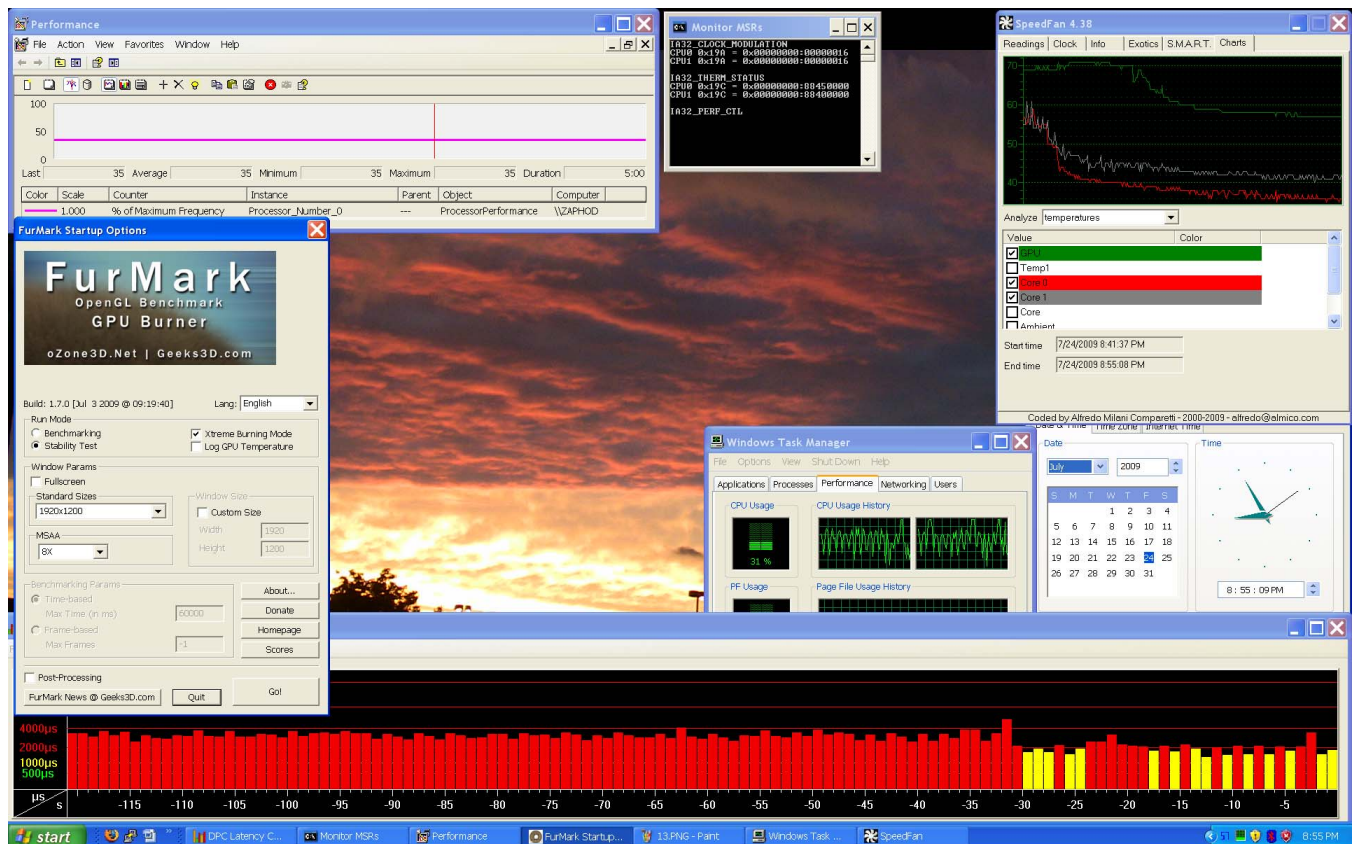
The next few captures show the transitions, every 30 seconds, reversing the Software-controlled Clock Modulation. Now at 37.5%.

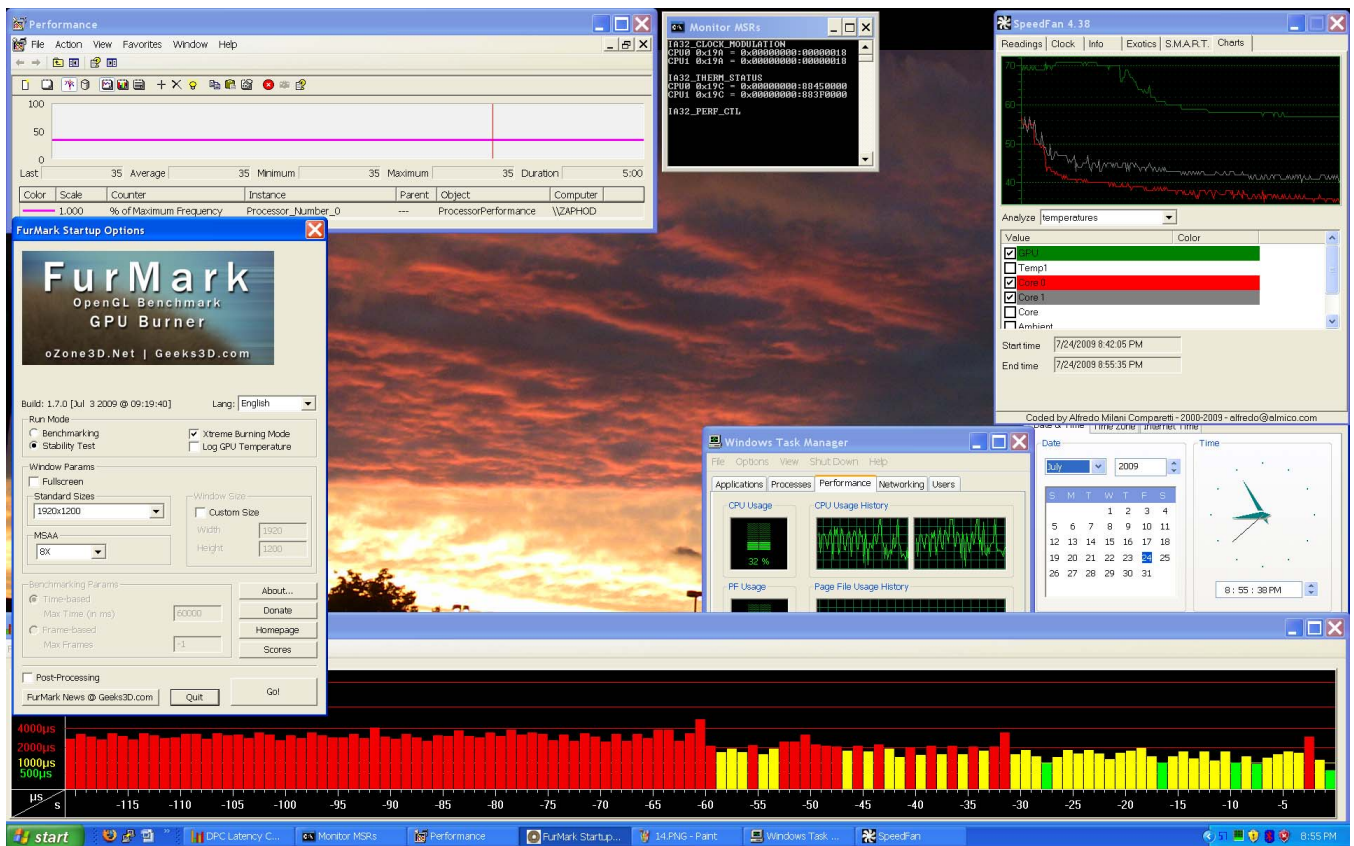
Now at 50% modulation.

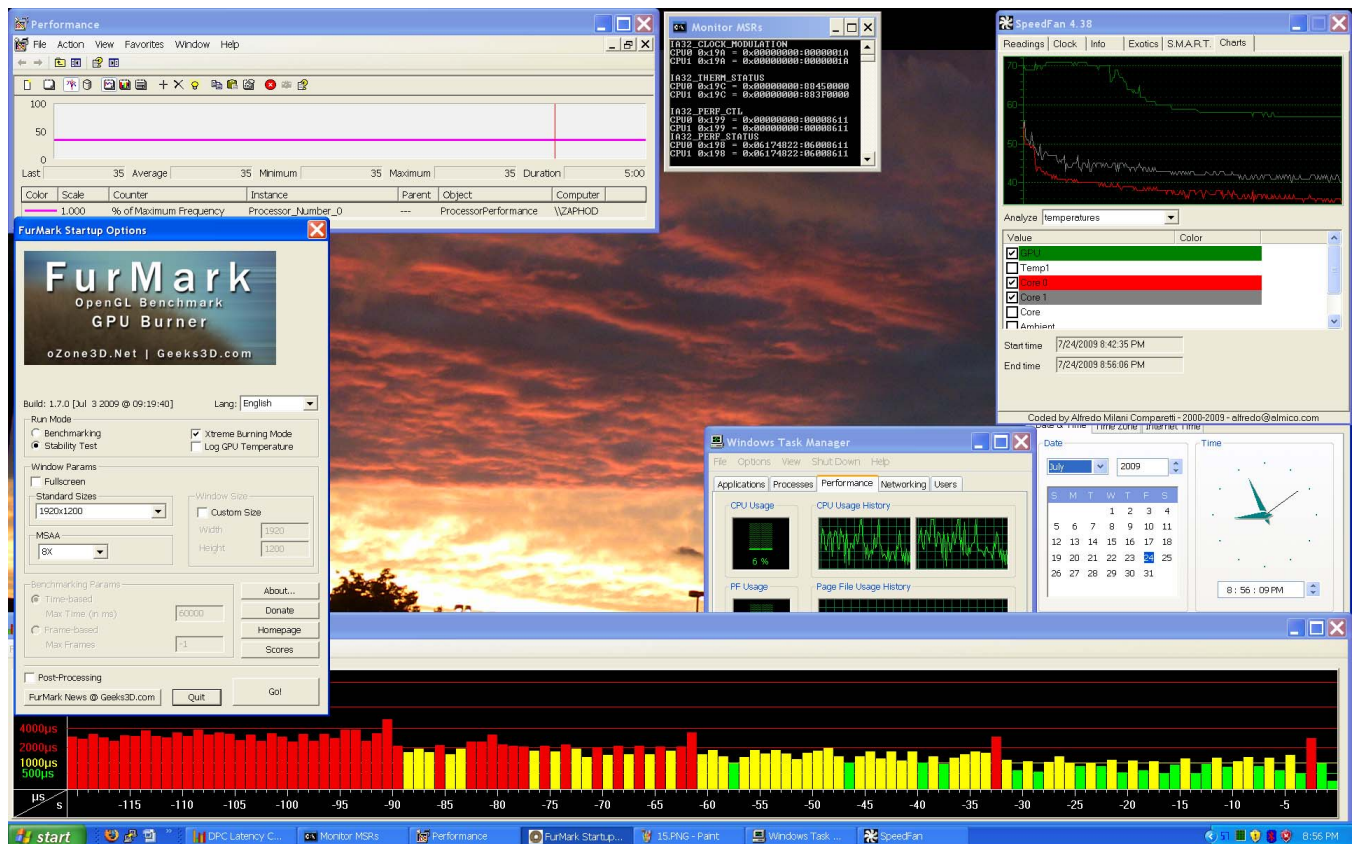
Now at 62.5% modulation.

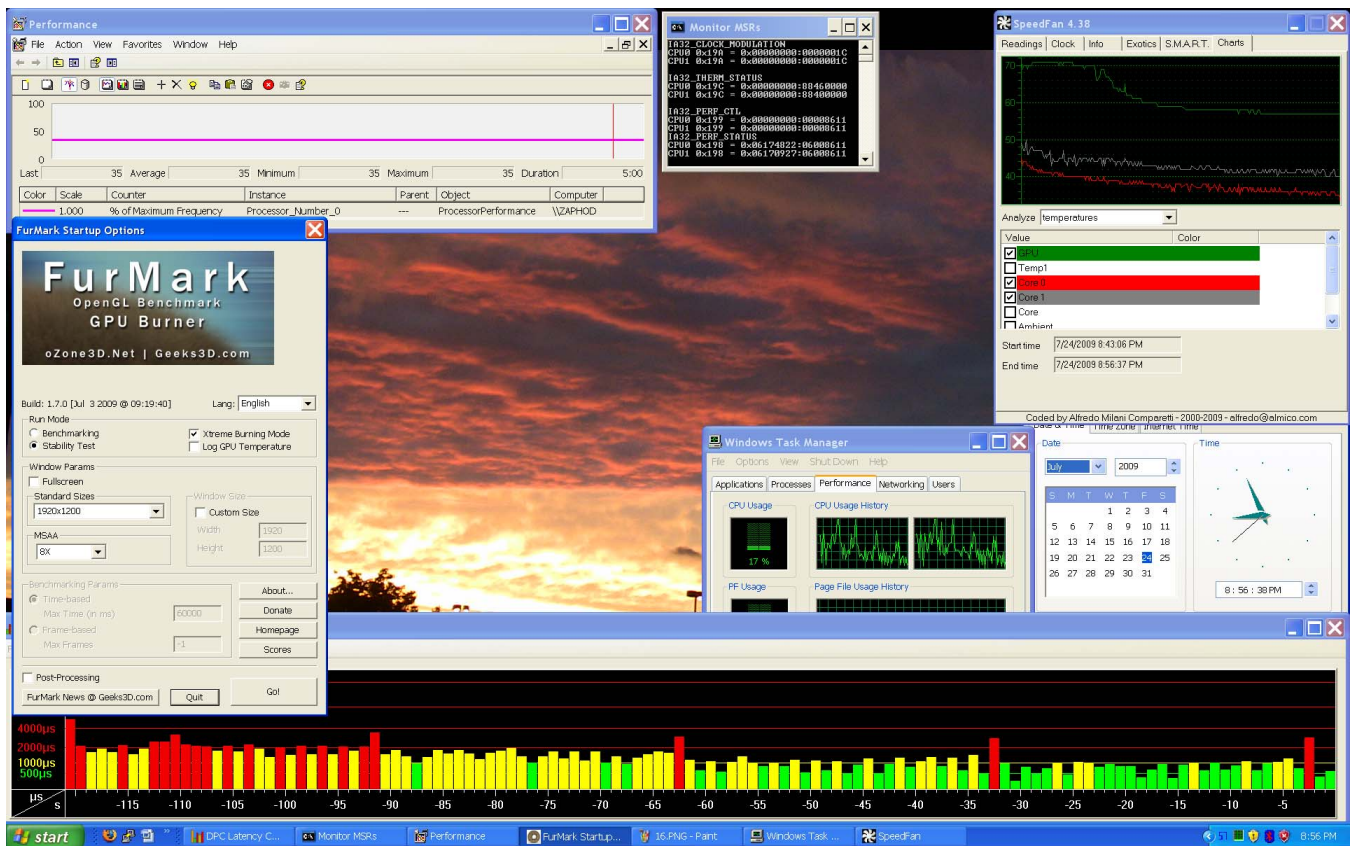
Now at 75% modulation.

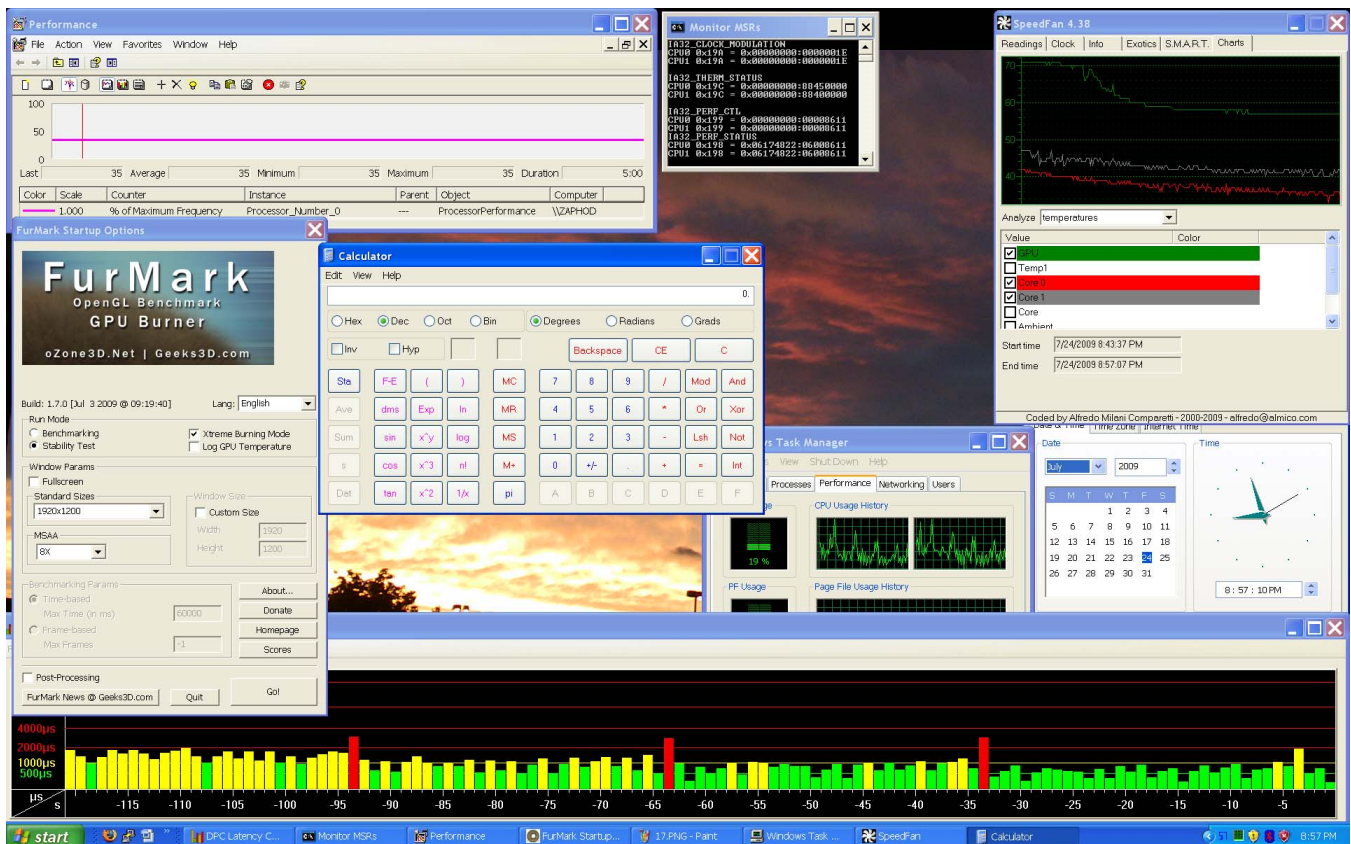
Now at 87.5% modulation. Note that a Windows Calculator window has been started (though no operation was initiated yet). To further demonstrate how little connection there is between the system's throttling and the CPU core temperatures, a long-term calculation process will be started to elevate CPU temperatures (factorial calculation of a large number). Screen captures will show that all the throttling measures will continue to be reversed even in the face of rising CPU core temperatures.

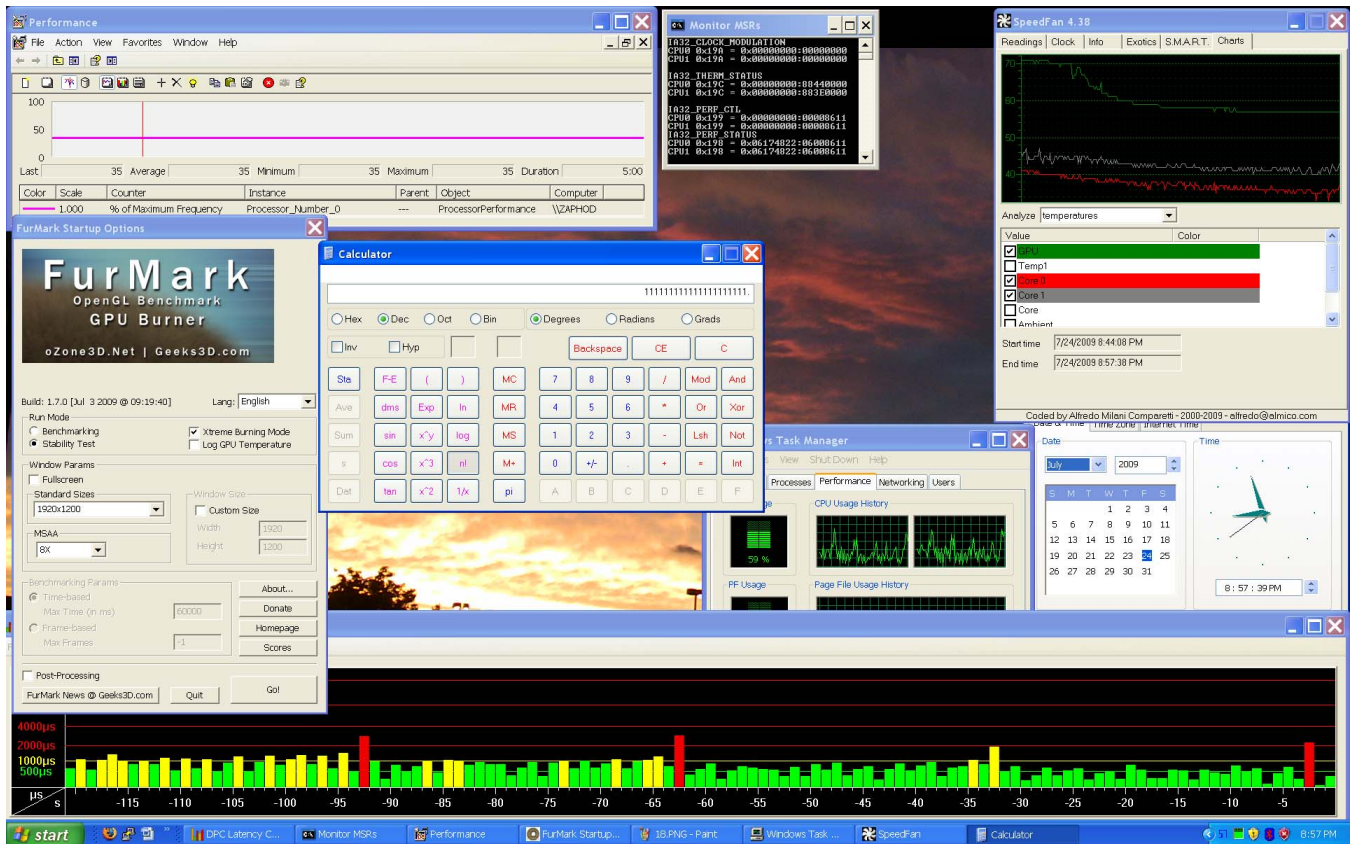
Software-controlled Clock Modulation is now turned off. Reversal of P-state transitions are next. The calculation of $11111111111111111111!$ is started in Windows Calculator.

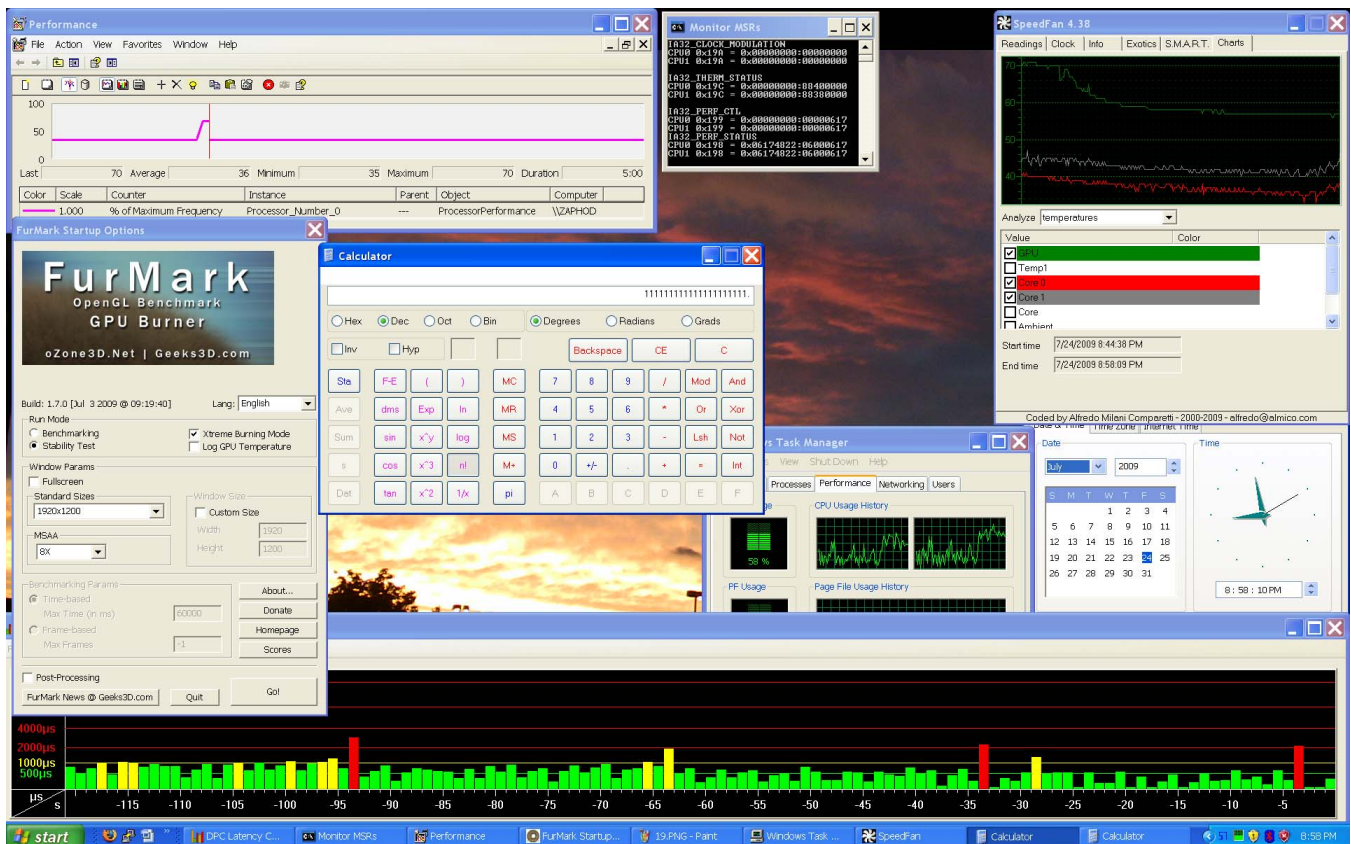
The transition from P3 to P2 is shown (Front Side Bus frequency is restored and CPU performance is now at 70% of total capacity). Note that CPU core temperatures are now on the rise.

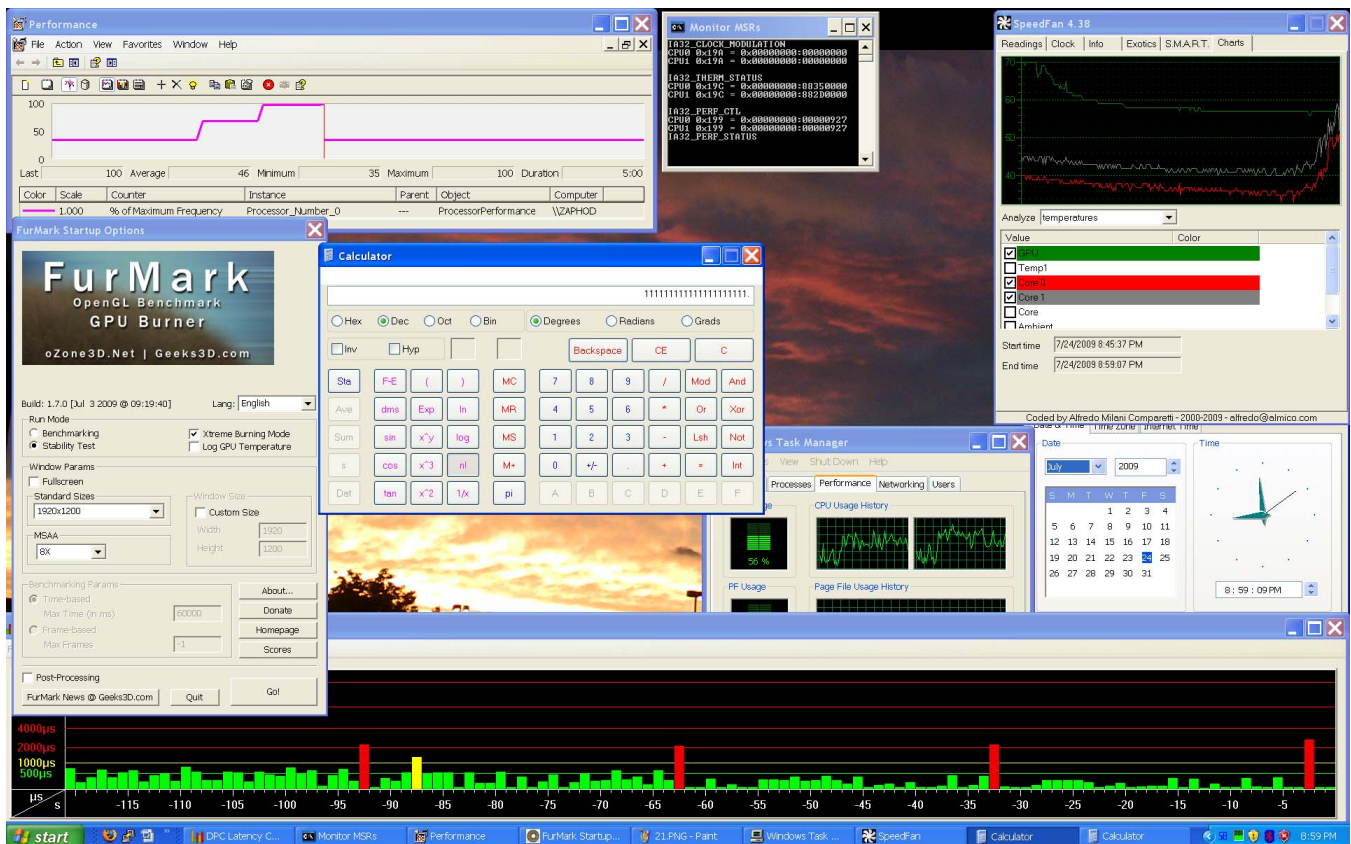
The final transition restoring the system to full processing capacity. Again note that core CPU temperatures are taking off, but this last dethrottling step still took place. However, while the correlation between GPU temperature and system throttling is much higher than for CPU temperatures, the next few screen captures demonstrate that there is nonetheless some finite CPU temperature correlation. At this point a second Calculator process is started, with the same long-term calculation, to bring both CPU cores to 100% utilization and escalate the CPU core temperatures.

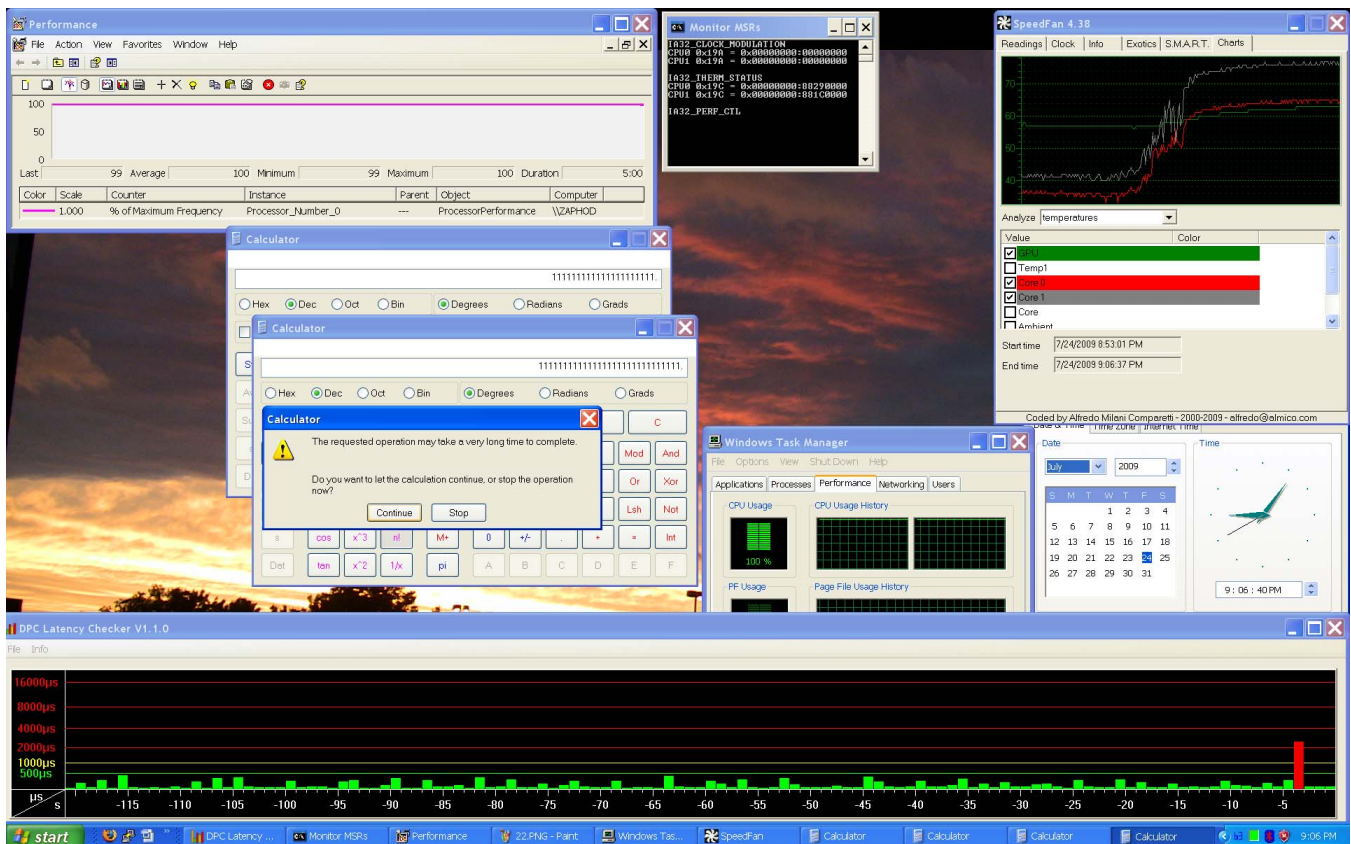
About 7 minutes later, the GPU is at 63°C (warmed somewhat by the CPU, which is nearby on the motherboard), but not near the 69°C that was required to trigger throttling before. Yet throttling is indeed being triggered, with the first event having just occurred in the screen capture.

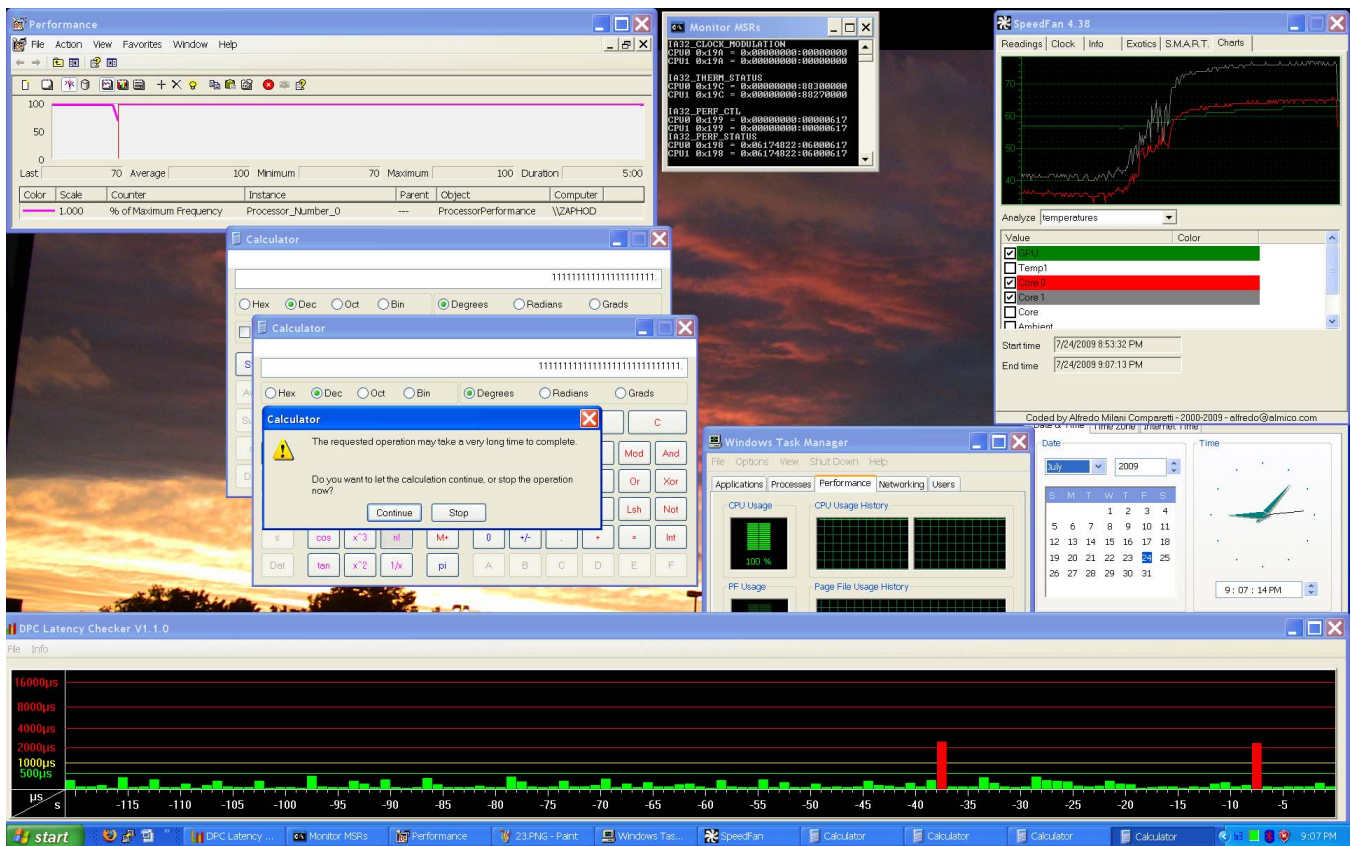
The next performance state transition takes place on schedule, as before, now down to 70% capacity.

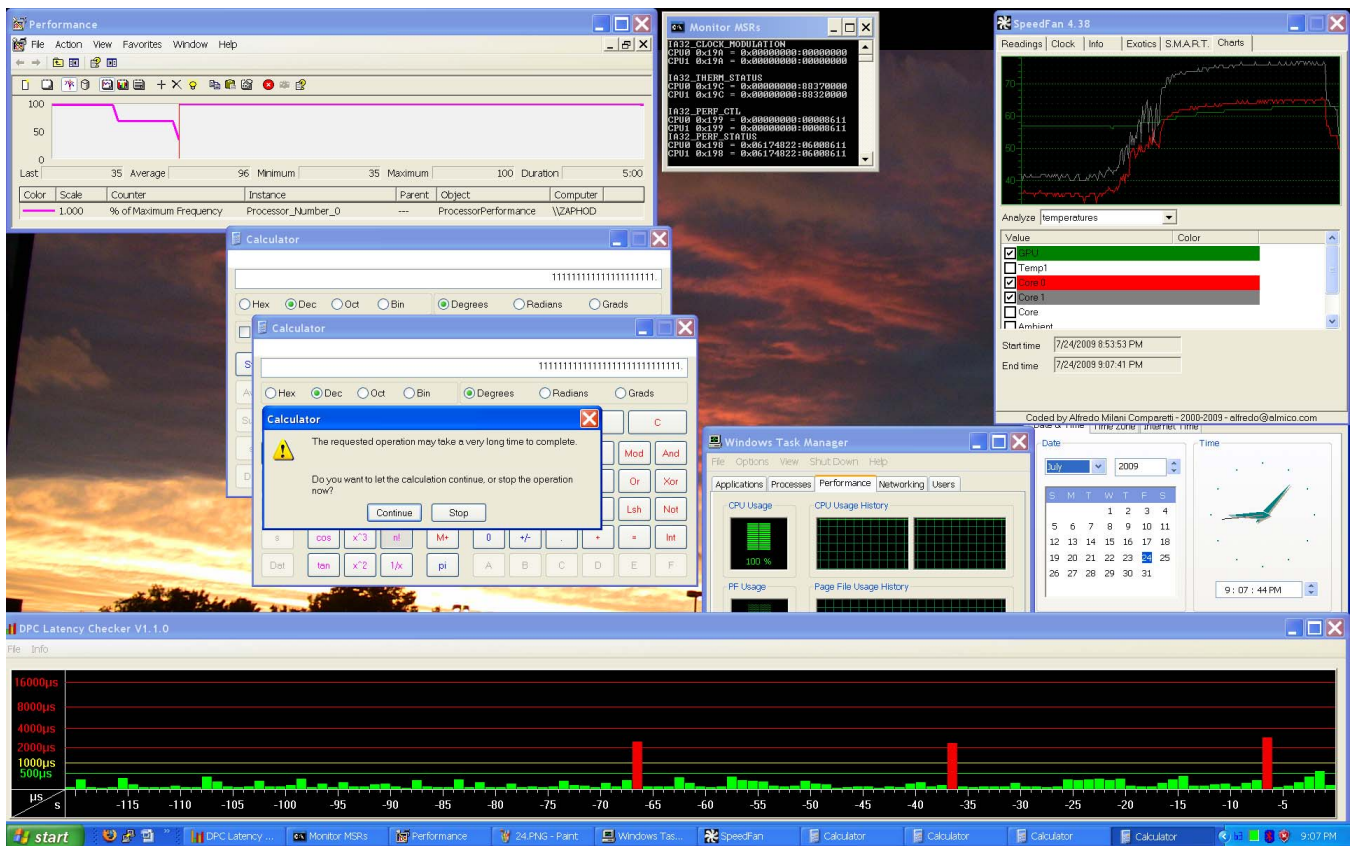
The transition to P3 and 35% capacity (along with halving of the FSB clock frequency)

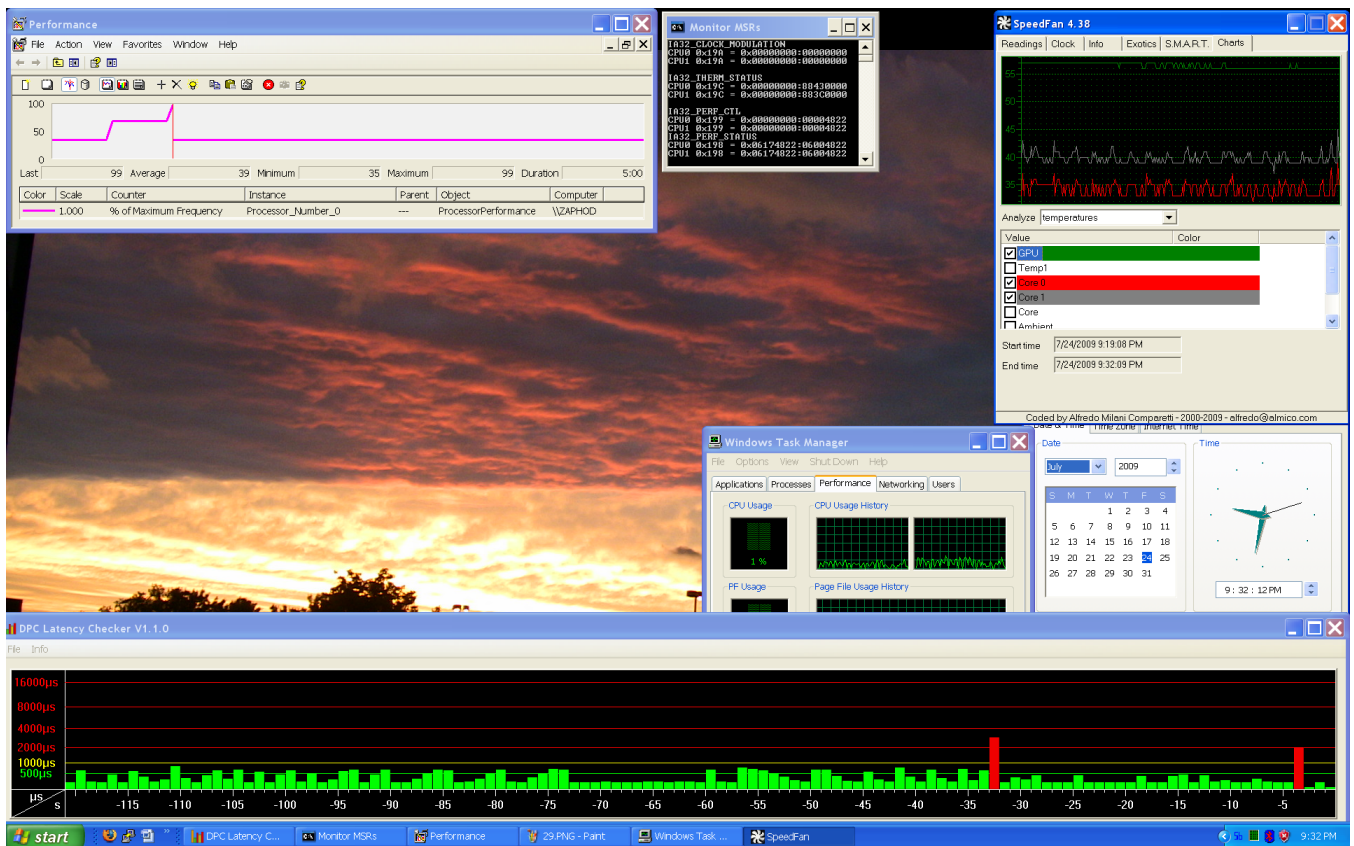
30 seconds later, right on schedule, the transition from state P2 to P1.

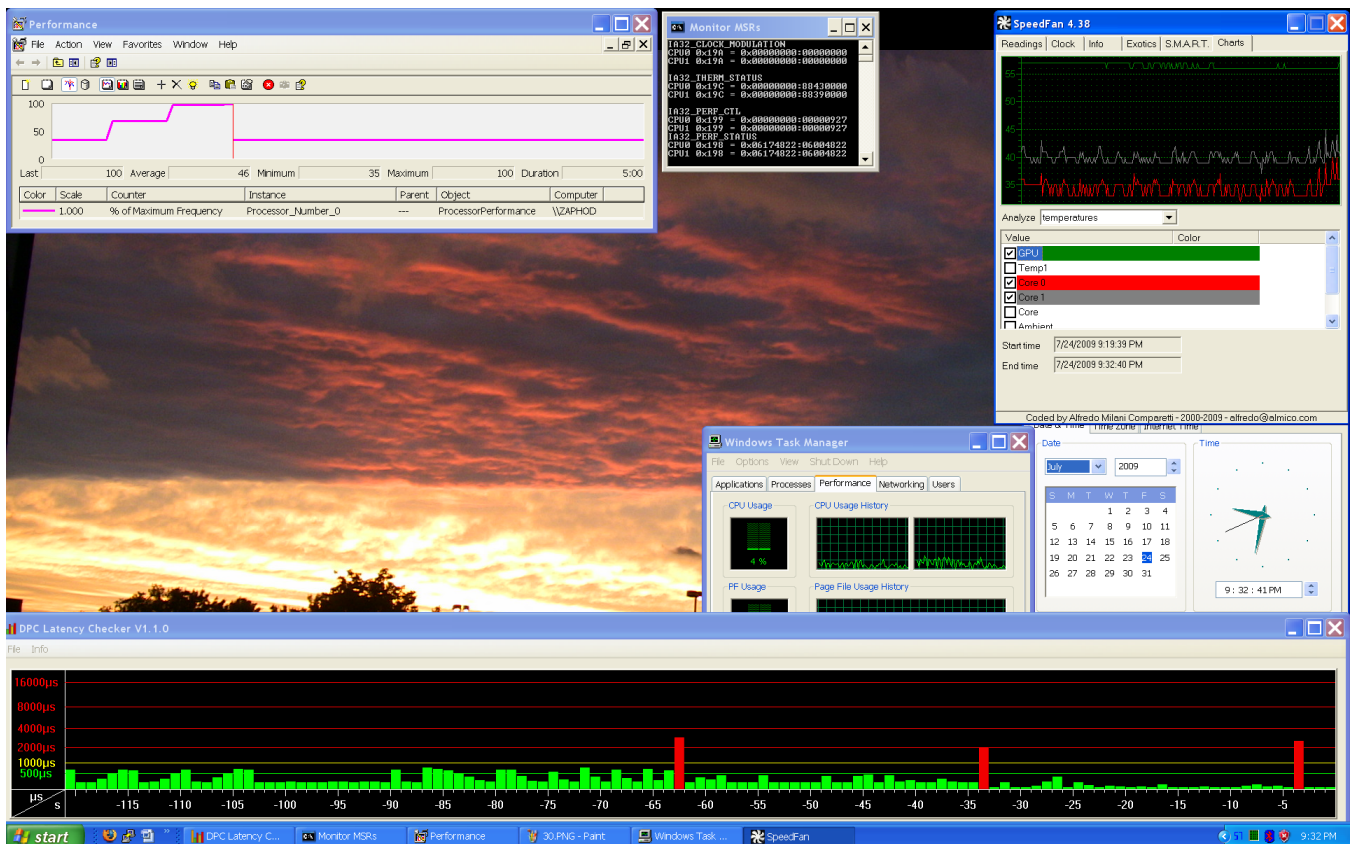
Finally, the last throttling step is reversed (with the continuing influence of the external desk fan) and the system is back to full processing capacity. That completes this test session.

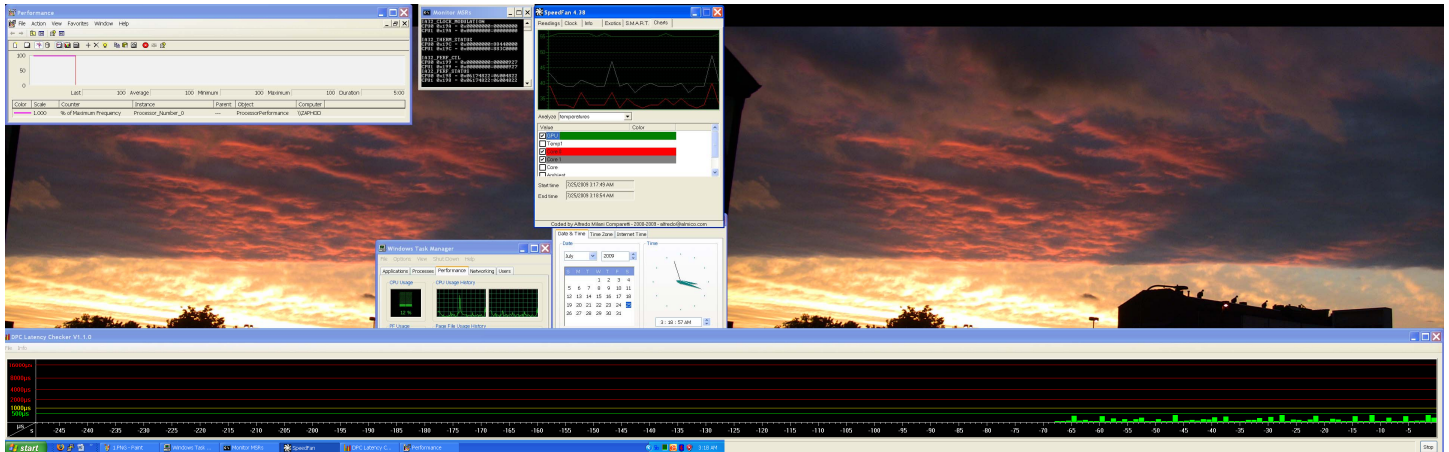
This first screen capture above, taken just before testing started, shows no throttling in effect yet, GPU temperature around 55°C, CPU core temperatures averaging below 40°C, CPU latency under 500 μ S and low processor utilization.

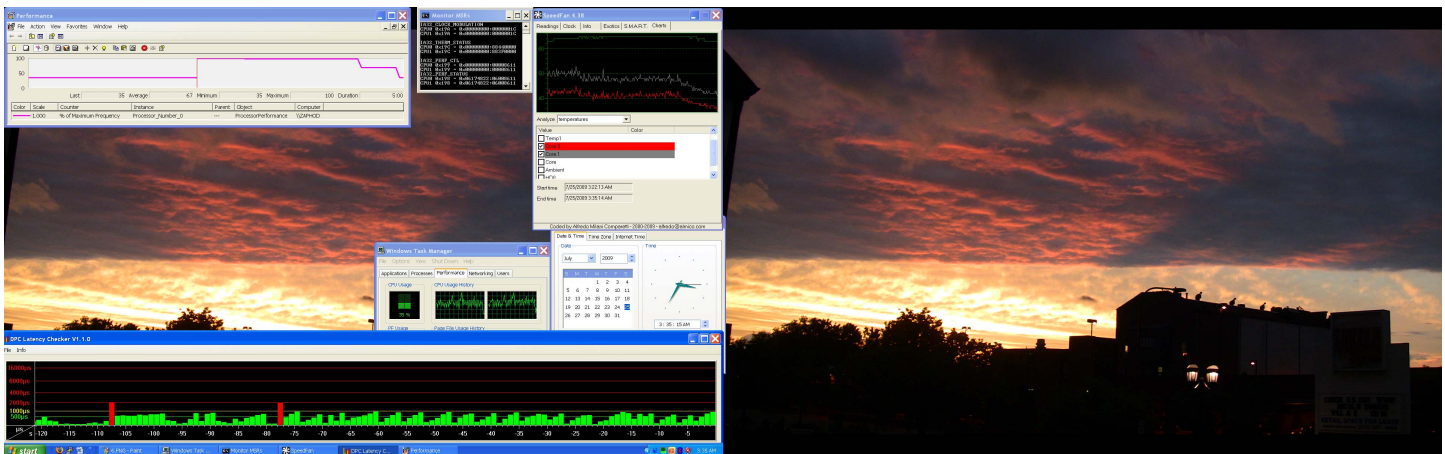
About one minute and 15 seconds later, it becomes apparent that no additional throttling will likely take place. Both GPU and CPU temperatures are falling and Software-controlled Clock Modulation is holding at 75%. The text output batch file was ended just before this capture to allow for cooling so that throttling reversal can be observed.

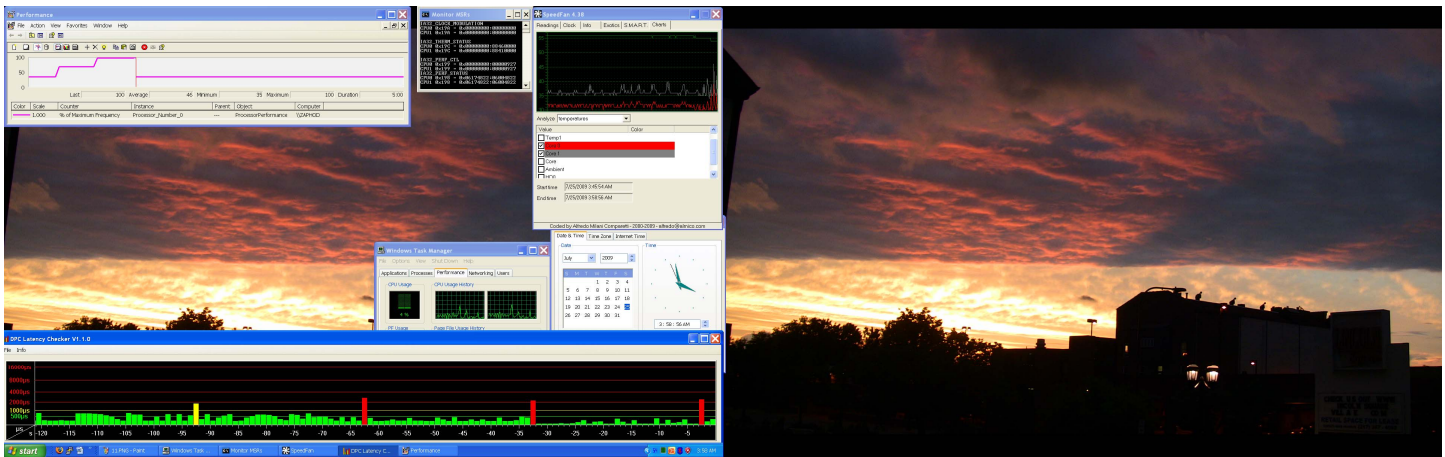
More than 20 minute later, throttling reversal finally began. The above screen capture shows the final four dethrottling events, restoring the system to full processing capacity.
