Performance loss during normal operation in a Dell Latitude E6500 laptop due to processor and bus clock throttling

Randall Cotton - recotton@earthlink.net
Revision 1.1 - July 31, 2009
© 2009 Randall Cotton

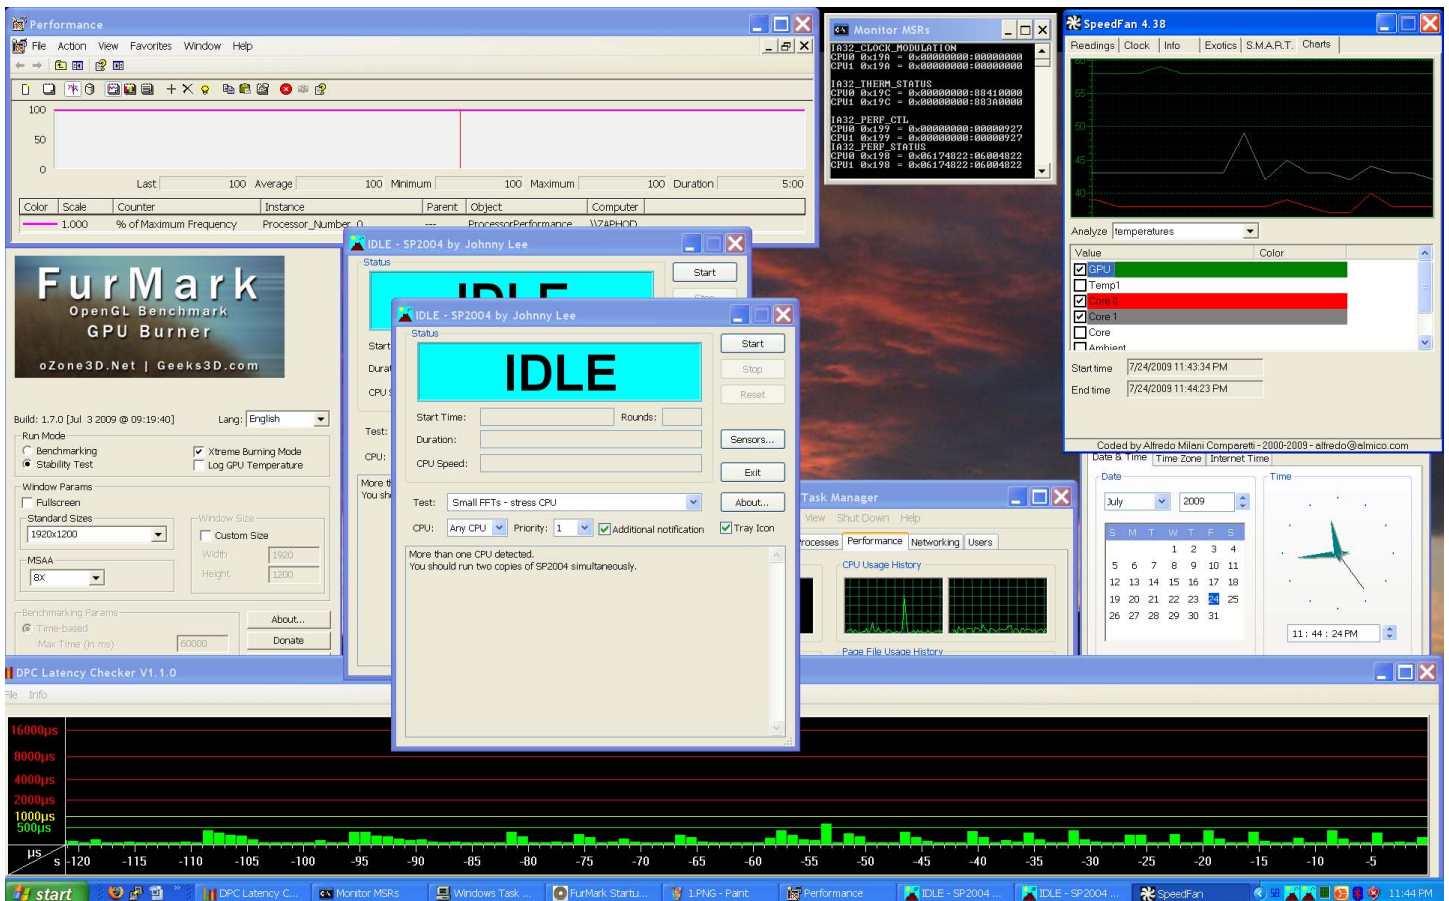
The screen capture above was taken just before testing began. Both FurMark and Stress Prime 2004 will be used to exercise the system since prior testing showed that neither utility alone was sufficient to trigger throttling. The ambient room temperature for this test was about 28°C.

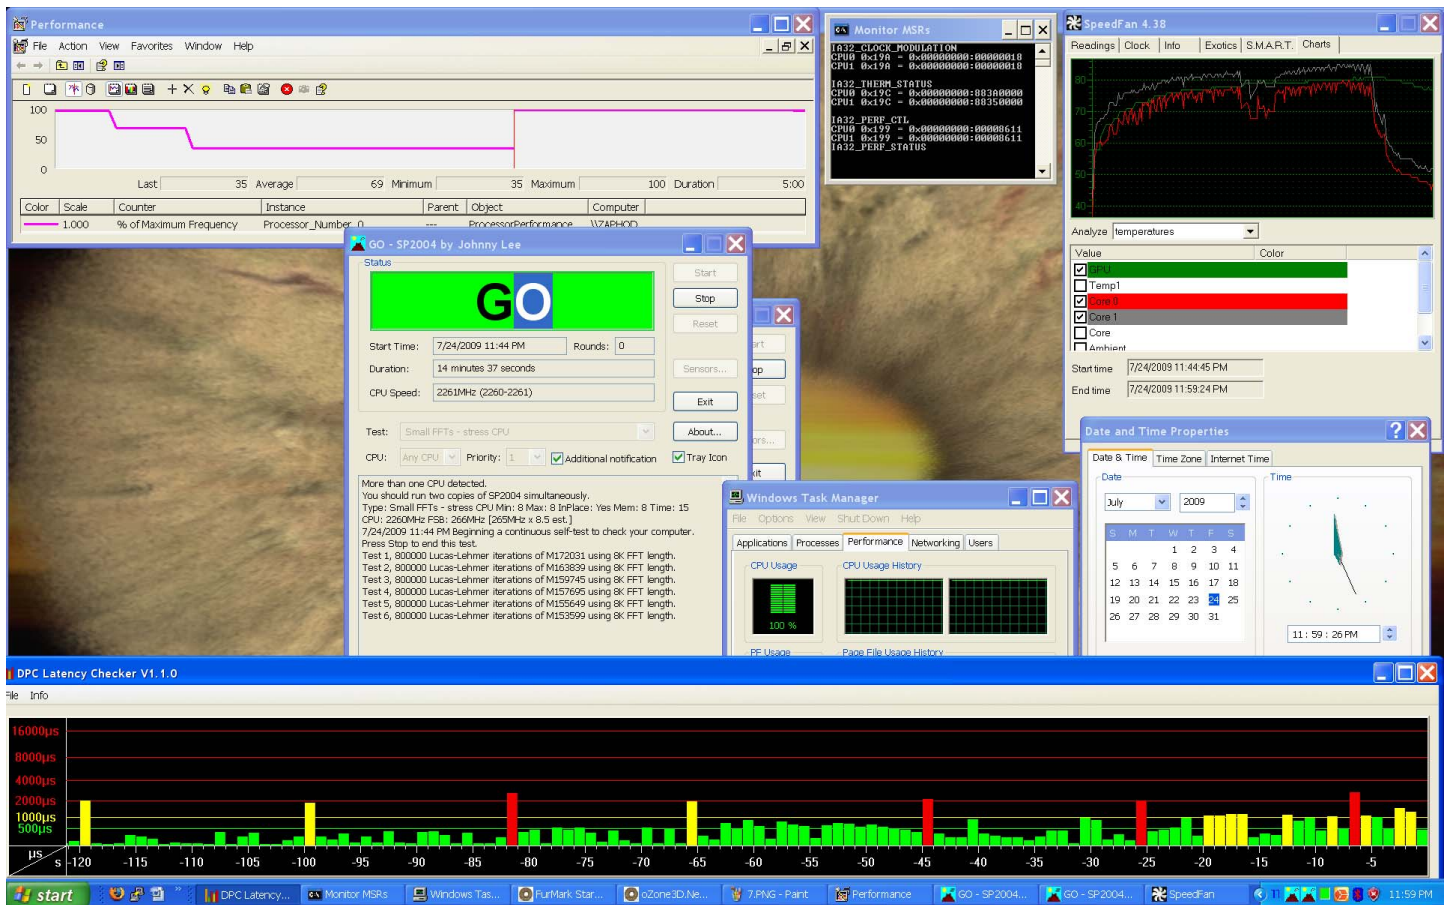
Here we can see how DPC Latency Checker recorded the occurrence of the first 7 throttling events. The remaining three throttling events are shown in the next capture.

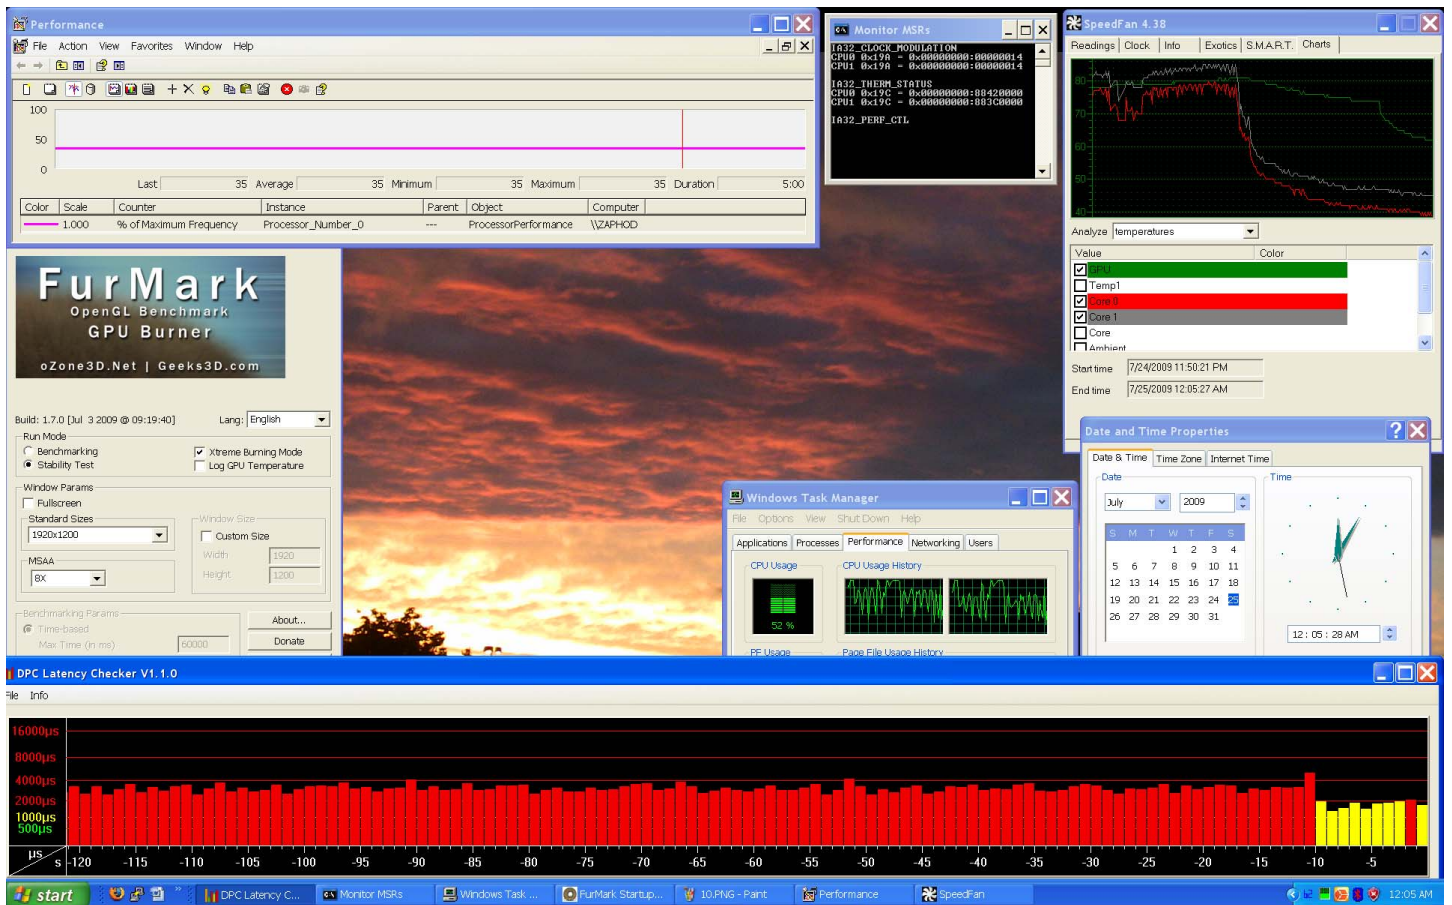
The remaining 3 throttling steps are shown to have occurred here, leaving the system fully throttled (12.5% of the P3 State, or about 100MHz overall, compared to its 2261MHz capacity). Both the FurMark and Stress Prime utilities were stopped just after this capture.

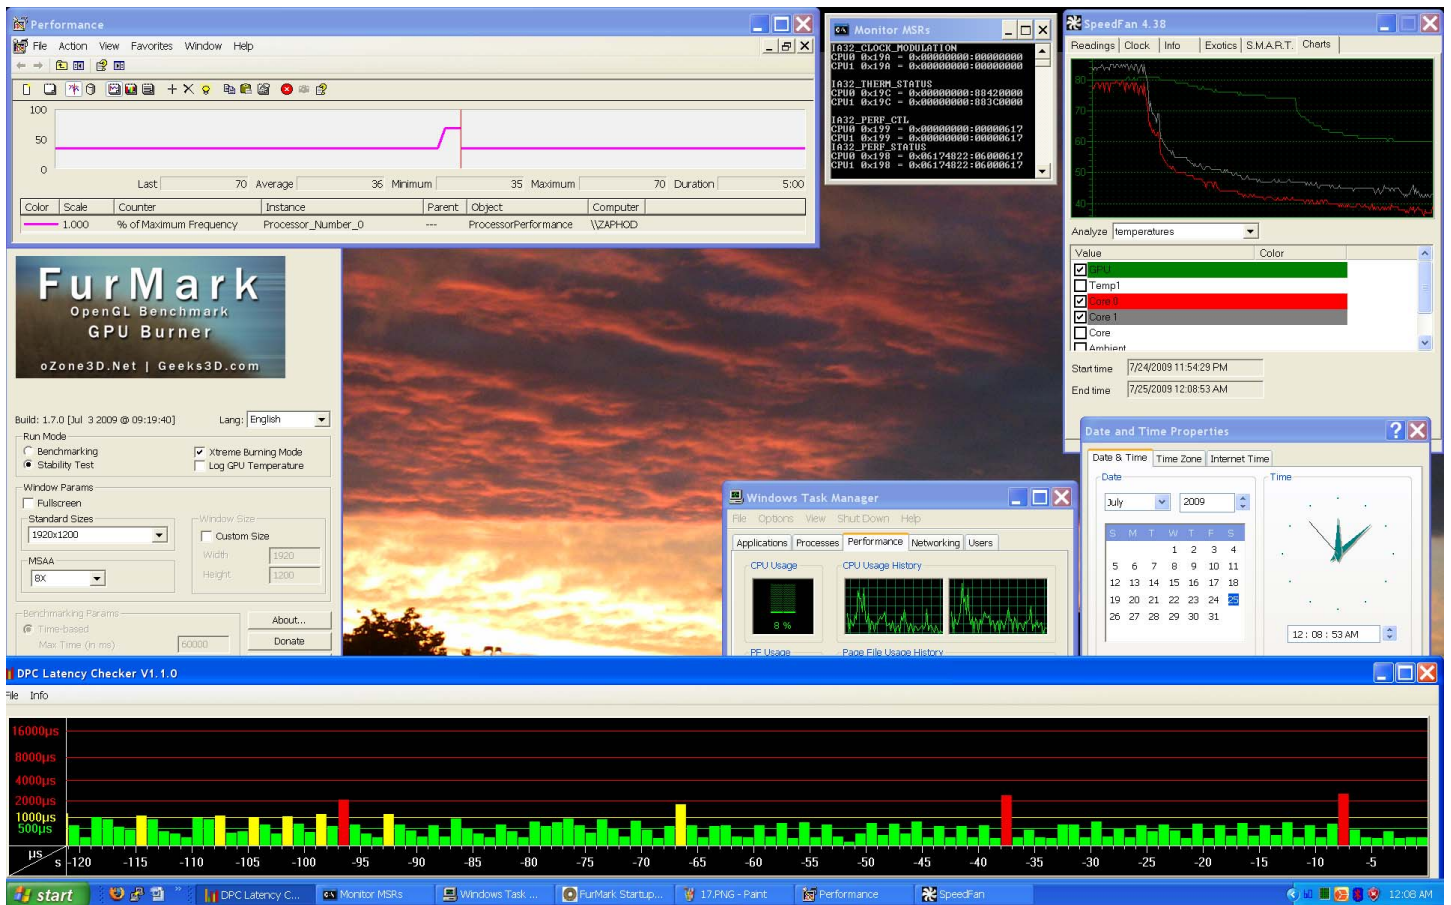
About 4 minutes later, unclocking begins and proceeds as usual, progressively reversing the throttling steps at 30 second intervals.

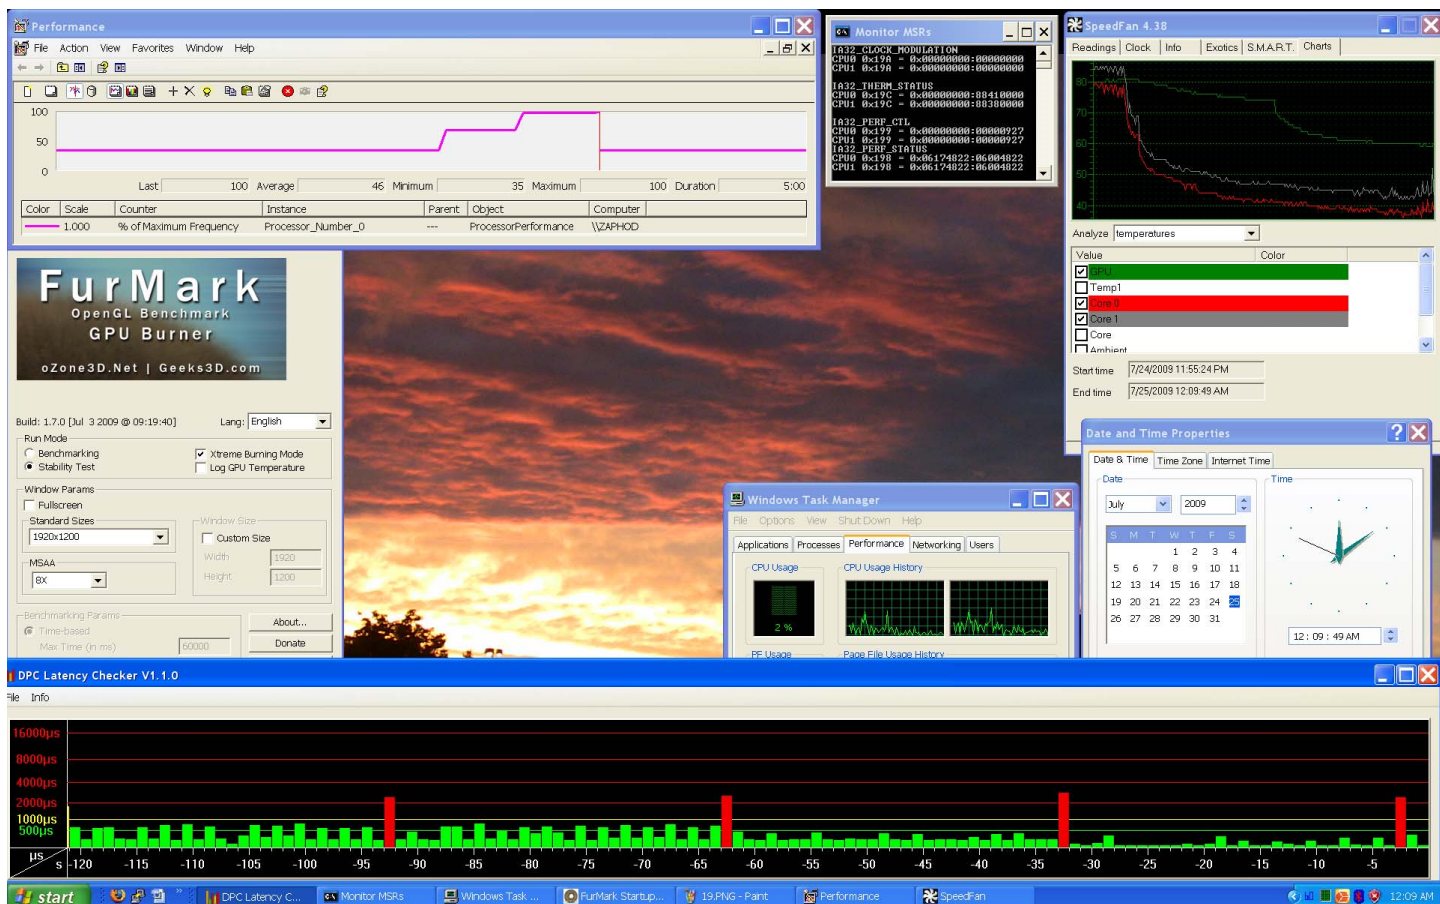
Here is the status after 3 more upclocking events.

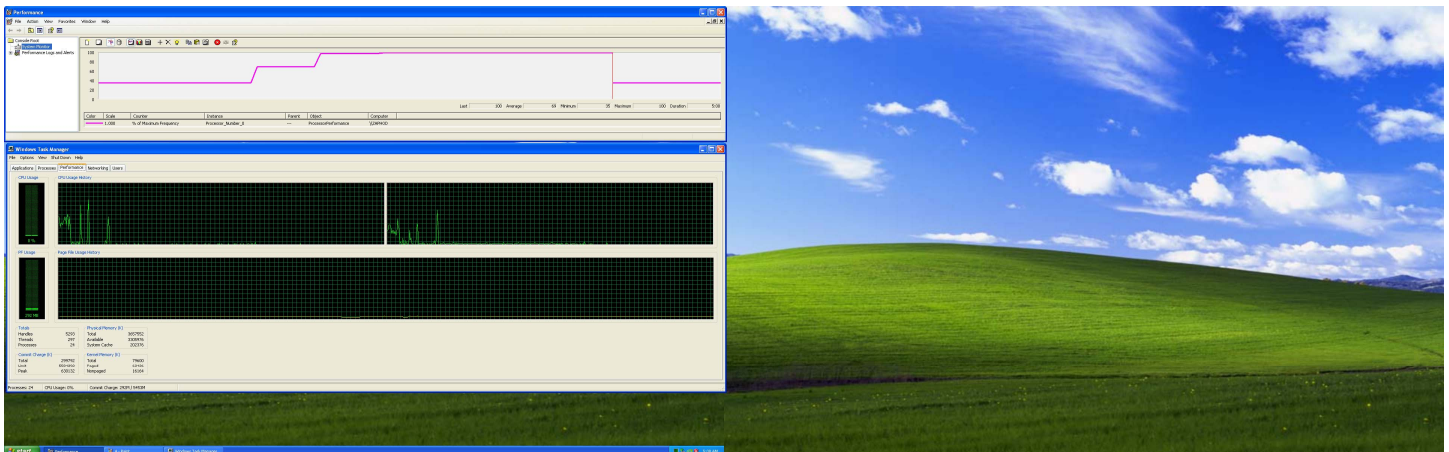
Though it took longer to trigger throttling in this case, half an hour later the system was throttled down to at least 35% of its true capacity. It wasn't possible to measure whether Software-controlled Clock Modulation was engaged since third-party software was not a part of this test by design. However, it stands to reason that this is the same throttling mechanism observed in prior tests, particularly since the throttling events occurred at the usual 30 second intervals (the P1→P2 and P2→P3 transitions were separated by 60 and 90 seconds, respectively). The batch file was stopped immediately after the screen capture above.
